# Annual Marine Oil Pollution Report for the year 2022

- CleanSeaNet Satellite-Based Oil Spill Detection inside Icelandic Exclusive Economic Zone and Other Pollution or Potential Pollution Related Information Reported by the Icelandic Coast Guard

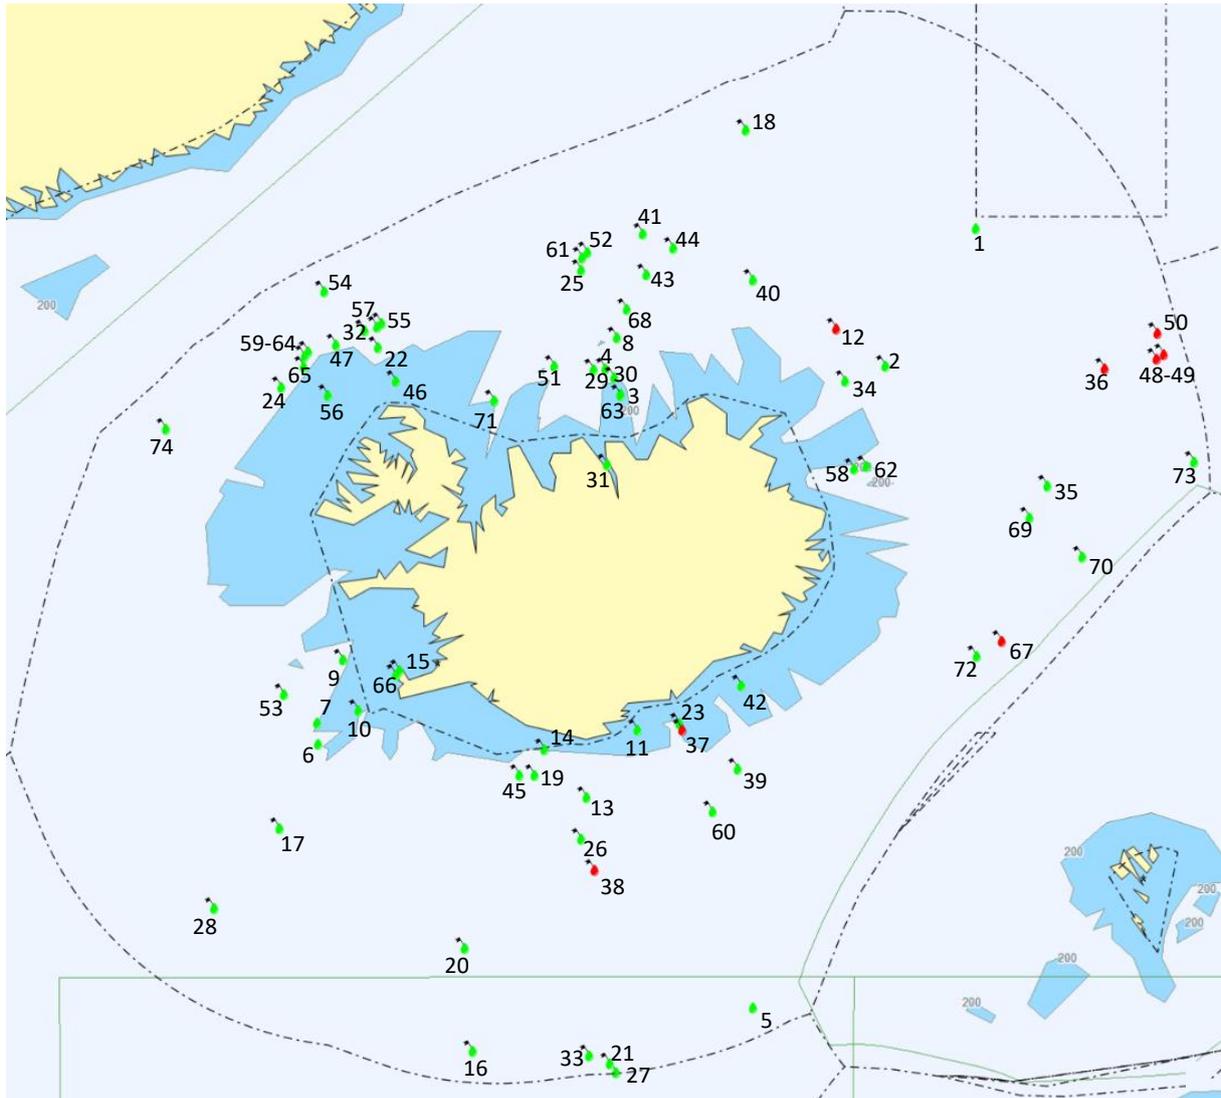
Figure 1: Overview of detected possible oil spills within the Icelandic Exclusive Economic Zone. Only detections inside the EEZ are numbered and provided feedback to in this report. EMSA (2023).

The numbered possible oil spills in figure 1 refer to the list of feedback.

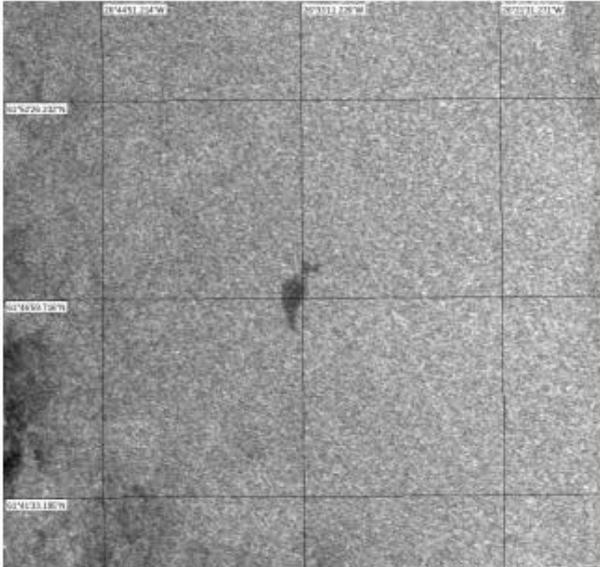
<small>Data and Products © STECOPROUD, INSTITUTE OF EARTH SCIENCES OF THE UNIVERSITY OF ICELAND AND ASSOCIATES LTD 2022 - All Rights Reserved EMSA/KSAT is an official track of the Columbus Space Agency</small>					
29	2022-08-08 18:51:55Z	66°44.53'N	018°33.91'W	0.460306	1	B	<b>Reason for no verification:</b> Considered a

<p>lookalike. The aligned fishing vessel had discharged water from the hold while underway. The detection is assessed to stem from fishing activity.</p>

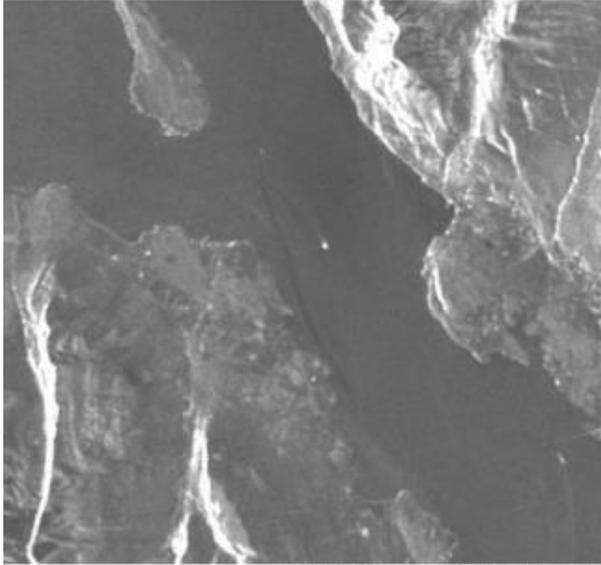
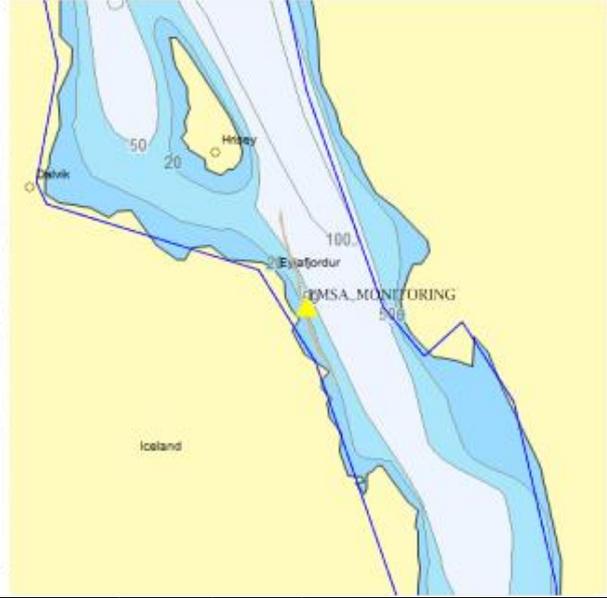
<p>Contains modified Copernicus Sentinel data 2022, processed by KSAT.</p>				
31	2022-08-10 18:35:20Z	65°55.91'N	018°17.59'W	0.968717	1	B	<p><b>Mineral oil confirmed.</b> The vessel connected to</p>

the detection confirmed that fuel oil had overflowed through the air vent and following been discharged. Amount discharged was estimated about 1-10 liters.

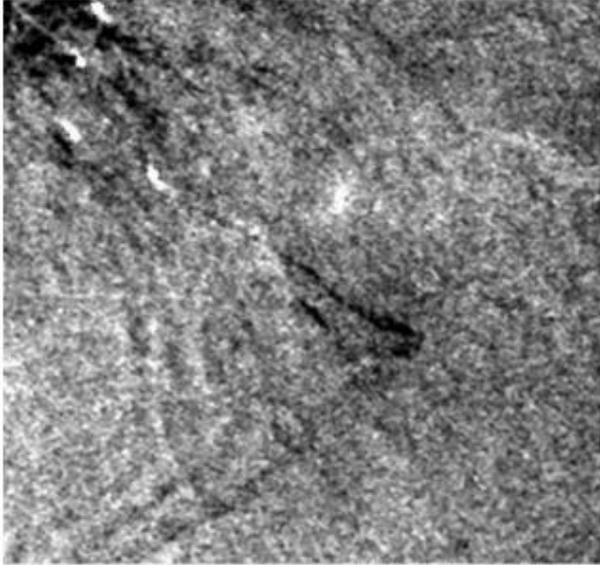
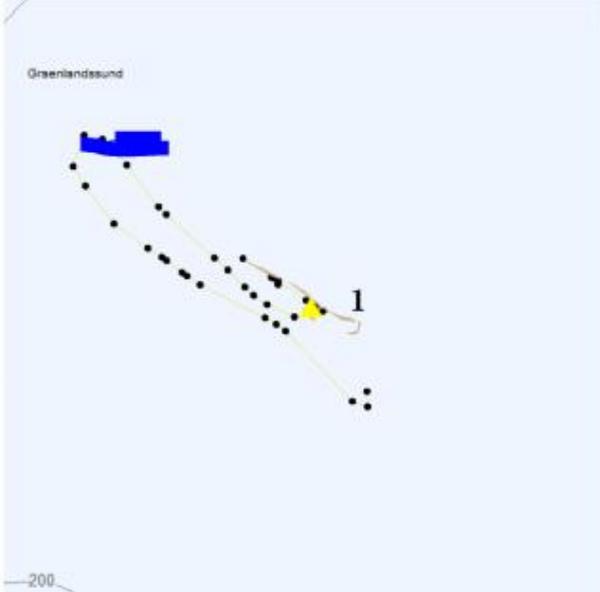
32	2022-08-13 19:00:17Z	67°04'N	023°23.19'W	0.695079	6	B	<b>Fish oil confirmed.</b> Captain of the fishing vessel connected to the detection called back and informed that they were producing fish oil on board and when a hose, connecting tanks, broke, 30-50 liters had leaked onto the deck and from there to the sea through the bilge pump.

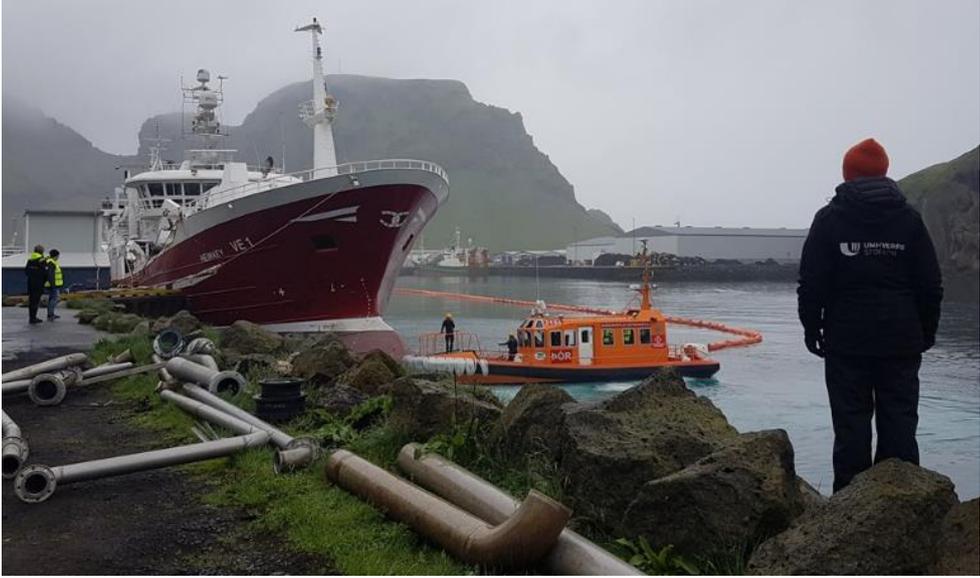
<p><i>Figure 3, (Mengunarvarnaæfing 2022, www.ust.is, 8. June 2022).</i></p>
<p>22 Sep</p>	<p>Communication exercise with MRCC Faroe Islands including pollution warning and pollution reporting.</p>

<p>2 Jun</p>	<p>The Environment Agency, the Icelandic Coast Guard, and the Icelandic Transport Authority conducted the yearly functional exercise together with the port of Westman Islands, the ICE-SAR Association, and the South Iceland Health Department.</p>
