Annual Marine Oil Pollution Report 2018

- CleanSeaNet Satellite-Based Oil Spill Detection inside Icelandic Area of Interest and Other Pollution or Potential Pollution Related Information Reported by the Icelandic Coast Guard

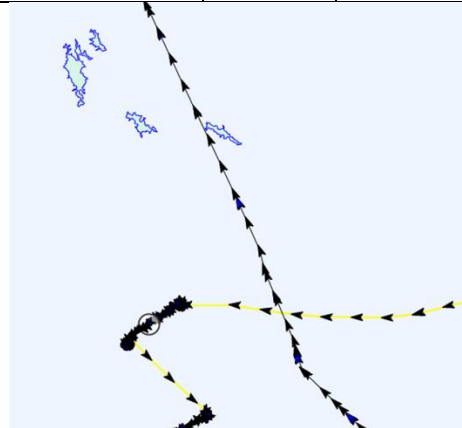
18	1806080015_2	2018-06-08 08:05:26	66°20'19"N	025°53'31"W	0.38	1	B	Possible source: yes Possible cause: Fishing activity. A fishing vessel west of Iceland reported a malfunctioning drainage hole from which fish liver and guts went overboard. On-site observation: Icelandic Coast Guard Maritime Surveillance Aircraft flew over position at 12:14 returning a clean SLAR picture.

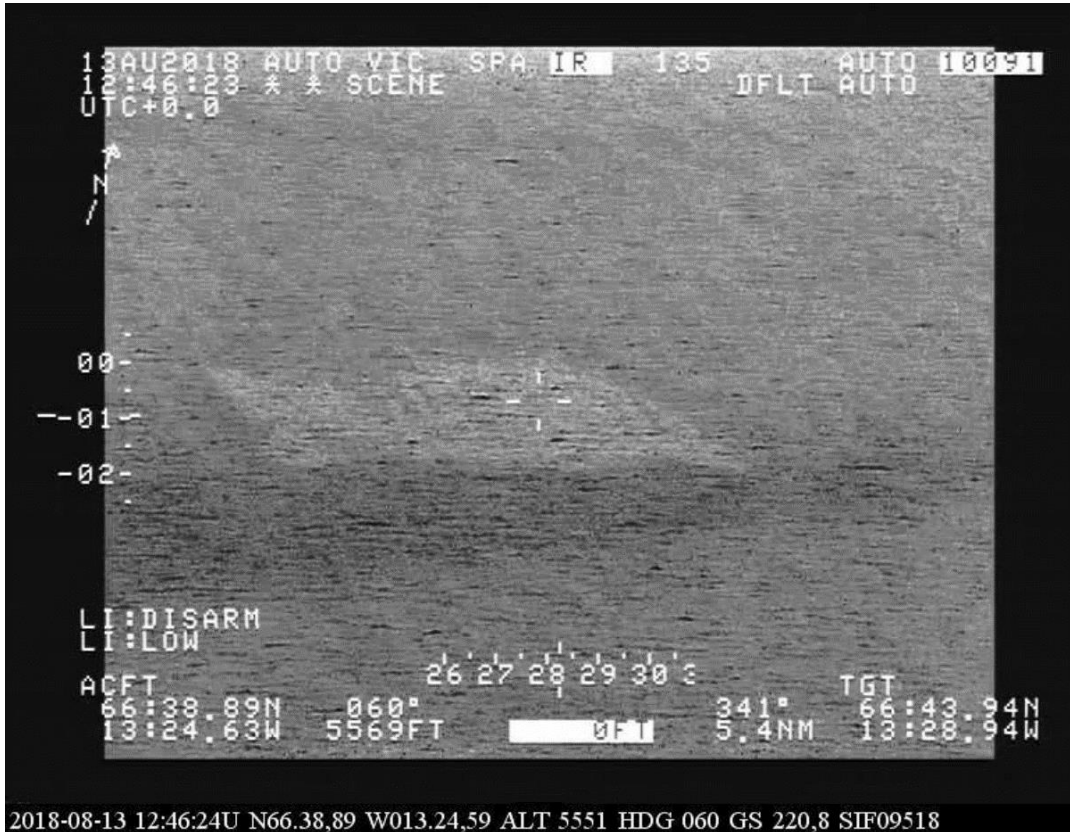
could not identify the oil slick in the image, the non-reporting is not classified as a false negative. We can though see from the incident that oils spills can not always be identified in fx windless areas. The size of the slick was reported to be about one nm long and 300-400 meters wide. The oil spill was reported from one witness to be heavy fuel oil.
	During a maritime surveillance flight a possible oil spill was detected 33 nm NE of Langanes. One trawler 12 nm from position was contacted but possible cause not identified. The side looking airborne radar of the aircraft was out of order and no further investigation was feasible by the aircraft.

13/8	2018-08-13 12:46:24U N66.38,89 W013.24,59 ALT 5551 HDG 060 GS 220,8 SIF09518
13/8	Thin non-combatable oil slick observed in Faxi Bay. Coast guard helicopter scrambled to investigate.
21/9	Oil leaking from boat in Hafnarfjordur.
9/11	A vessel reports a brown weathered foaming oil slick on sea surface 57 nm from Dalatangi/pos 65°26,59'N - 011°18,47'W. Length about 0,3 nm. A history area query returned a number of possible sources.

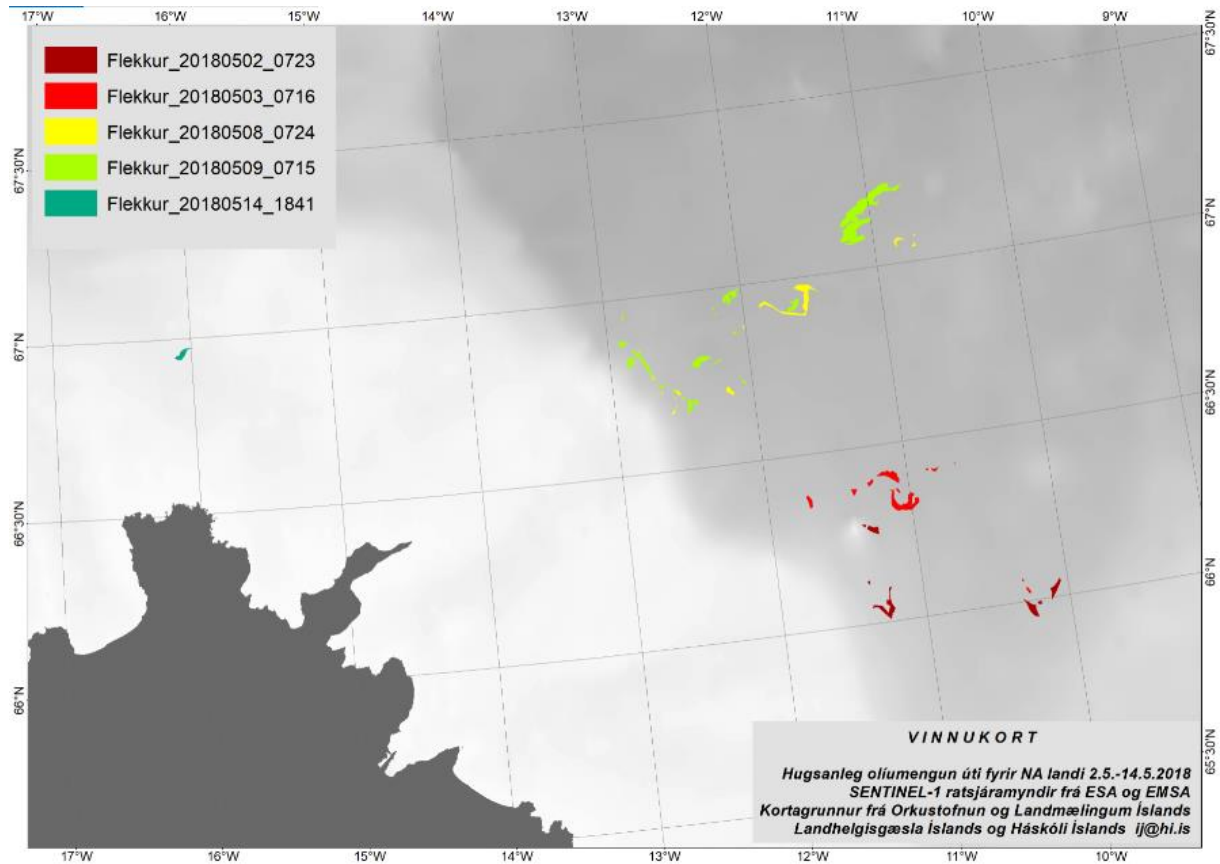
Figure 3: Map by Ingibjörg Jónsdóttir, Faculty of Earth Sciences, University of Iceland.

From 2 – 14 May the situation of several possible oil spills reported by EMSA was monitored by satellite imagery by ICG and Faculty of Earth Sciences, University of Iceland.
