Eyri, Arnarlax
B survey,
November 2022
(max biomass)

| Information client | | | |
|---|---|---|---|
| Title | Eyri, Arnarlax. B survey (max biomass, November 2022) | | |
| Report number | APN-64474.B01 | | |

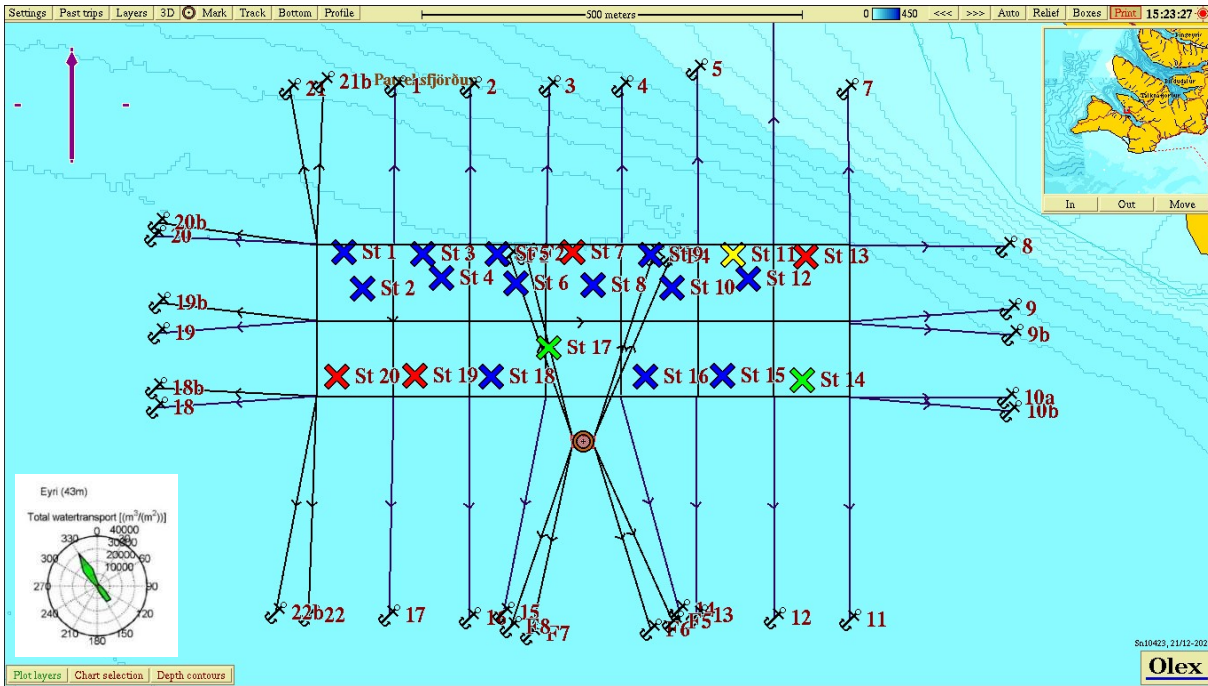
Figure 2. Site specific map of Eyri showing frame, mooring lines and farming area. Sampling stations st. 1 – 20 are marked with crosses. The color of each cross represents the environmental condition at the respective station following the classification as outlined in NS 9410:2016, chapter 7.11. Colour codes: Blue = very good, green = good, yellow = bad, red = very bad. Current rose placed in the lower left corner shows main current direction at 43 m (Gunnarsson, 2020b).

Based on the classification of sediment chemistry (ph/Eh) and the sensory assessments four stations of this survey received status 4 – "very bad", one station received status 3 – "bad", two stations received status 2 – "good" and thirteen station status 1 – "very good" (Figure 2).

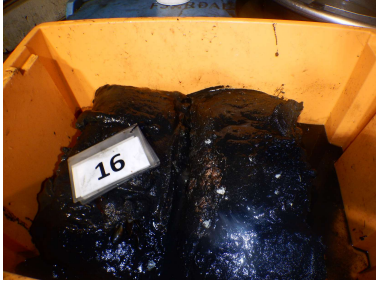
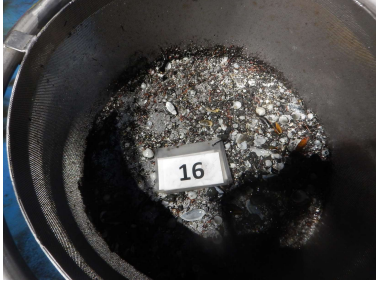
| <i>St 16</i> | <p>A yellow plastic container filled with dark, wet, clumpy material. A small white label with the number '16' is placed on top of the material.</p> | <p>A stainless steel sieve containing a dark, granular residue from sample 16. A small white label with the number '16' is placed in the center of the sieve.</p> |

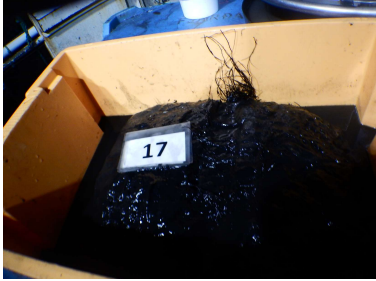
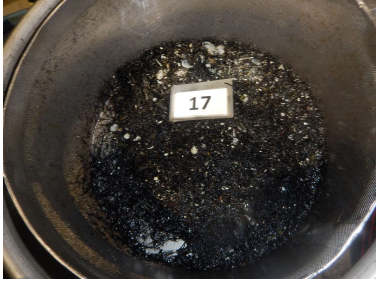
| <i>St 17</i> | <p>A yellow plastic container filled with dark, wet, clumpy material. A small white label with the number '17' is placed on top of the material.</p> | <p>A stainless steel sieve containing a dark, granular residue from sample 17. A small white label with the number '17' is placed in the center of the sieve.</p> |

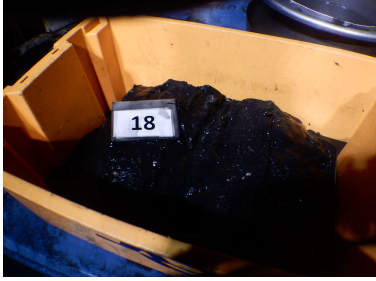
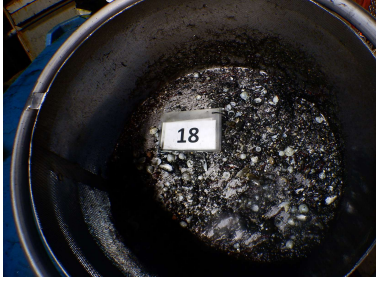
| <i>St 18</i> | <p>A yellow plastic container filled with dark, wet, clumpy material. A small white label with the number '18' is placed on top of the material.</p> | <p>A stainless steel sieve containing a dark, granular residue from sample 18. A small white label with the number '18' is placed in the center of the sieve.</p> |

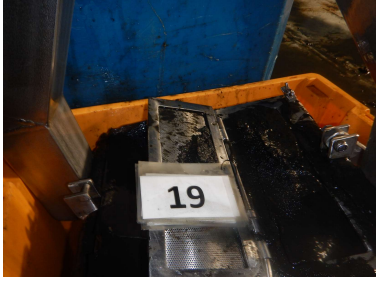
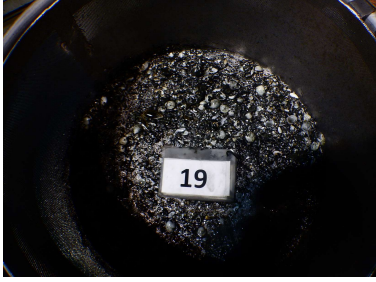
| <i>St 19</i> | <p>A yellow plastic container filled with dark, wet, clumpy material. A small white label with the number '19' is placed on top of the material.</p> | <p>A stainless steel sieve containing a dark, granular residue from sample 19. A small white label with the number '19' is placed in the center of the sieve.</p> |

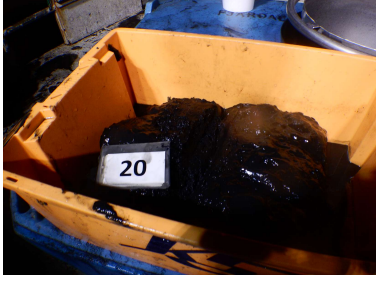
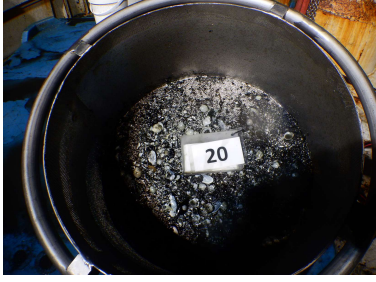
| <i>St 20</i> | <p>A yellow plastic container filled with dark, wet, clumpy material. A small white label with the number '20' is placed on top of the material.</p> | <p>A stainless steel sieve containing a dark, granular residue from sample 20. A small white label with the number '20' is placed in the center of the sieve.</p> |

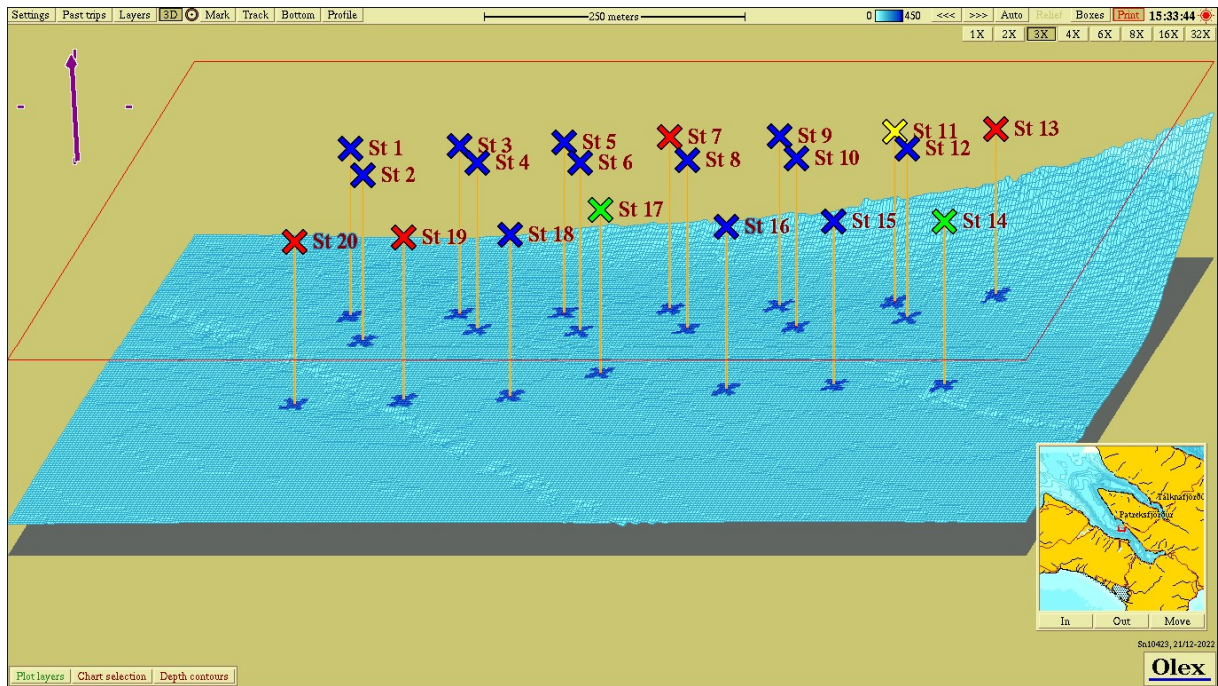
Figure 3. Bottom topography in 3D at Eyri with each sampling station according to info in Figure 1 and Table 4.
