Hringsdalur, Arnarlax
B survey,
April 2022
(post fallow)

Information client			
Title	Hringsdalur, Arnarlax. B survey (post fallow), April 2022		
Report number	APN-64042.B01		
Site name	Hringsdalur	Coordinates site	65°44,416N 023°45,777V
County	Barðastrandarsýsla	Municipality	Vesturbyggð
MTB-or estimated max biomass	9.600 tonnes	Site manager/contact	Silja Baldvinsdóttir
Client name	Arnarlax

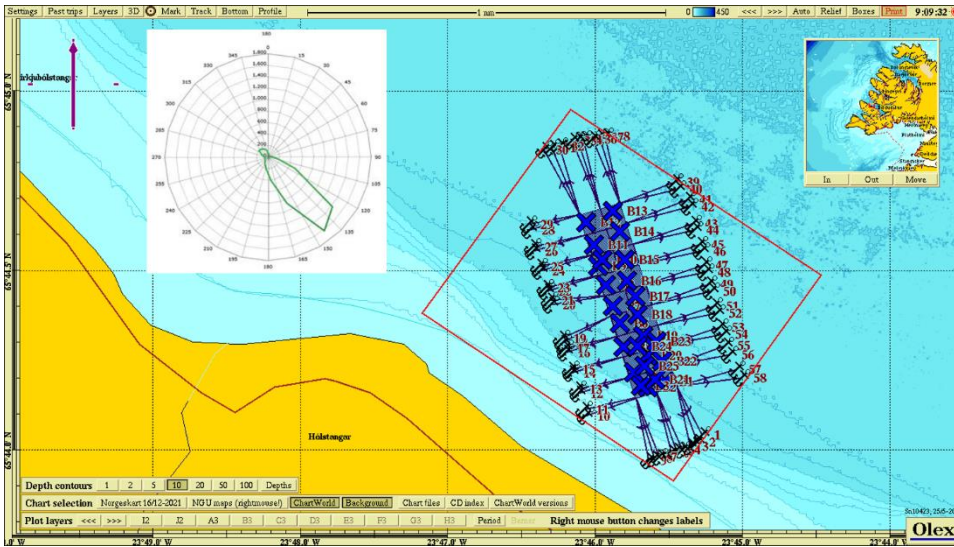
The placement of the 25 sampling stations is shown in Figure 2 with positions listed in Table 4. Station are distributed within the near zone of the new frame position following criteria outlined in NS 9410:2016. Depth beneath and in the close vicinity of the cage varies between 56– 88 m, with the deepest waters being located in the northern part of the frame. Sampling

stations were placed to represent the varied environmental conditions within the near zone and cover thus both the deeper and shallower areas. The sampling stations had a depth varying from 62 to 87 m. The placement of sampling stations is regarded to be in accordance with the requirements outlined in NS 9410:2016.

Figure 2. Site specific map of Hringsdalur showing frame, mooring lines and farming area. Sampling stations st. 1 – 25 are marked with crosses. The color of each cross represents the environmental condition at the respective station following the classification as outlined in NS 9410:2016, chapter 7.11. Colour codes: Blue = very good, green = good, yellow = bad, red = very bad. Current rose placed in the top left corner shows main current direction at 60 m (Moe, 2014).

Current measurements were undertaken in Jan-Feb 2014 at 60 m, which is the dispersing depth for Hringsdalur site (Moe, 2014). The dominating current at 60 m is in south-easterly direction (120-165 degrees) with a small counter current in opposite direction (Figure 2). Average current speed is 6 cm/s. Highest current speed is measured to be 29 cm/s and 2.54 % of the measurements are zero current.

Based on the classification of sediment chemistry (pH/Eh) and the sensory assessments all stations of this survey received status 1 – "very good" (Figure 2). The site therefore also receives as a whole the environmental status 1 – "very good".

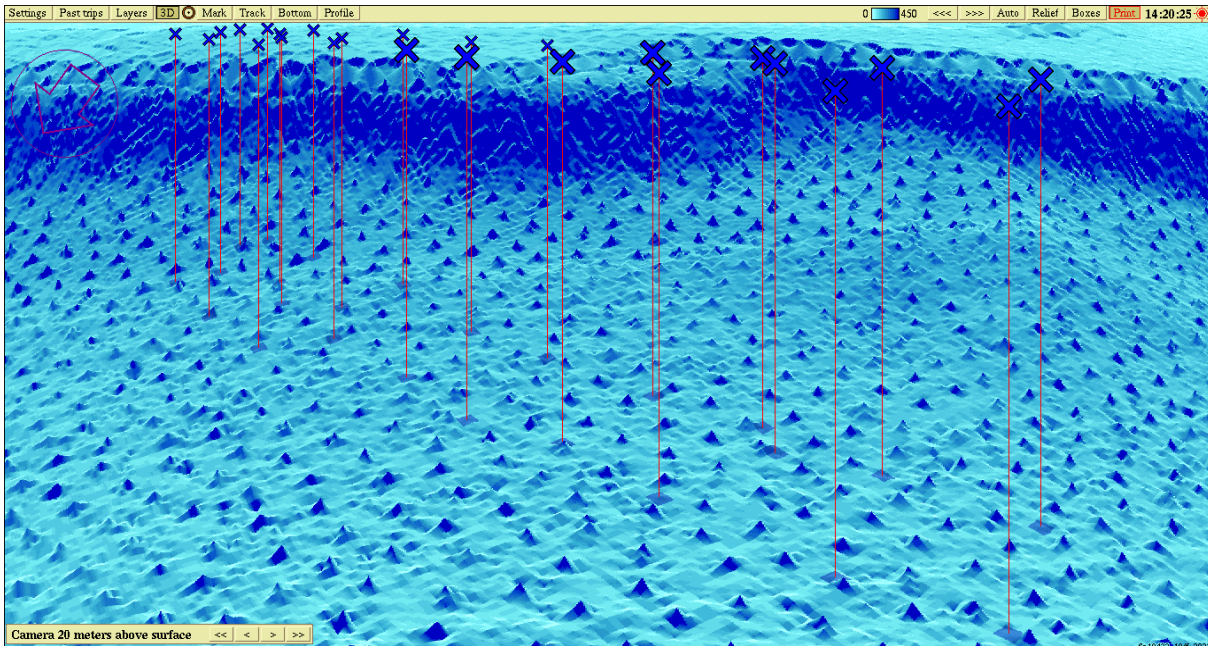
Figure 3. Bottom topography in 3D at Hringsdalur with each sampling station according to info in Figure 1 and Table 4.
