Eyrarhlíð 2, Arctic Sea Farm  
B survey,  
August 2023  
(fallow period)

Information client			
Title	Eyrarhlíð 2, Arctic Sea Farm B survey (fallow period), August 2023		
Report number	APN-65177.B01		
Site name	Eyrarhlíð 2	Coordinates site	65°55,489N 23°43,504V
County	Ísafjarðarbær	Municipality	Ísafjarðabær
MTB-or estimated max biomass	7.250 tonnes	Site manager/contact	Maria E. Chiarandini
Client name	Arctic Sea Farm ehf

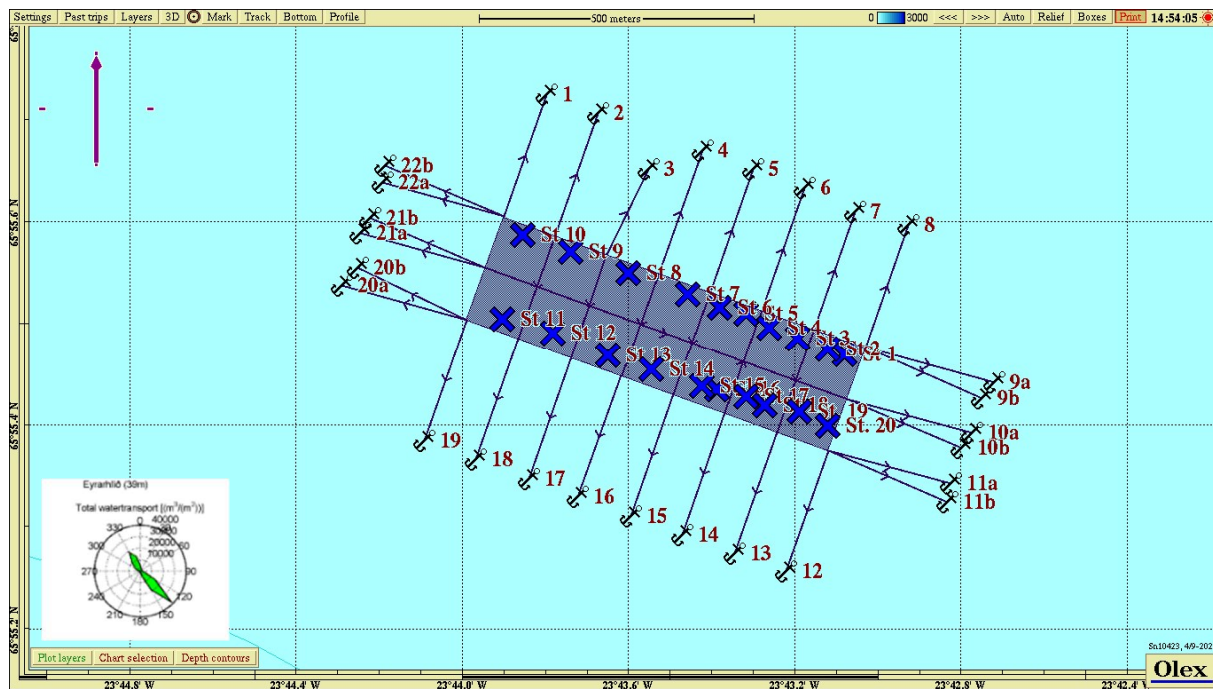
The placement of the 20 sampling stations is shown in Figure 2 with positions listed in Table 4. The number of sampling stations is based on the estimated max. biomass of 7.250 t for next generation farmed fish. Stations are distributed within the near zone of the new frame position following criteria outlined in NS 9410:2016. The typical depth in the local impact zone is in the range from 36 – 44 m. Sampling stations were placed to represent the varied environmental conditions within the near zone and cover thus both the deeper and shallower areas. The sampling stations had a depth varying from 38 to 43 m. The placement of sampling stations is regarded to be in accordance with the requirements outlined in NS 9410:2016.

Figure 2. Site specific map of Eyrarhlíð 2 showing frame, mooring lines and farming area. Sampling stations st. 1 – 20 are marked with crosses. The color of each cross represents the environmental condition at the respective station following the classification as outlined in NS 9410:2016, chapter 7.11. Color codes: Blue = very good, green = good, yellow = bad, red = very bad. Current rose placed in the lower left corner shows main current direction at 39 m (Gustavsson, 2019).

Based on the classification of sediment chemistry (pH/Eh) and the sensory assessments at the nineteen soft bottom stations received status 1 – "very good" (Figure 2).

Applying the indicator thresholds and classification outlined in NS 9410:2016 it is shown that the local impact zone at Eyrarhlíð 2 receives site status 1 – "very good" at the time of this B survey. Samples were collected with a Van Veen grab (0,025 m<sup>2</sup> at stations 1 – 10 and 0,1 m<sup>2</sup> at stations 11 - 20) at 20 stations distributed around the 14 cages which are placed in the mooring frame. One station was defined as hard bottom and neither parameter II (pH/redox) or parameter III (sensory) could be measured/assessed due to lack of sediment so defined as hard bottom. Out of the total 19 station were both parameters II and III could be assigned all sampling stations received status 1 – "very good" (Figure 2).

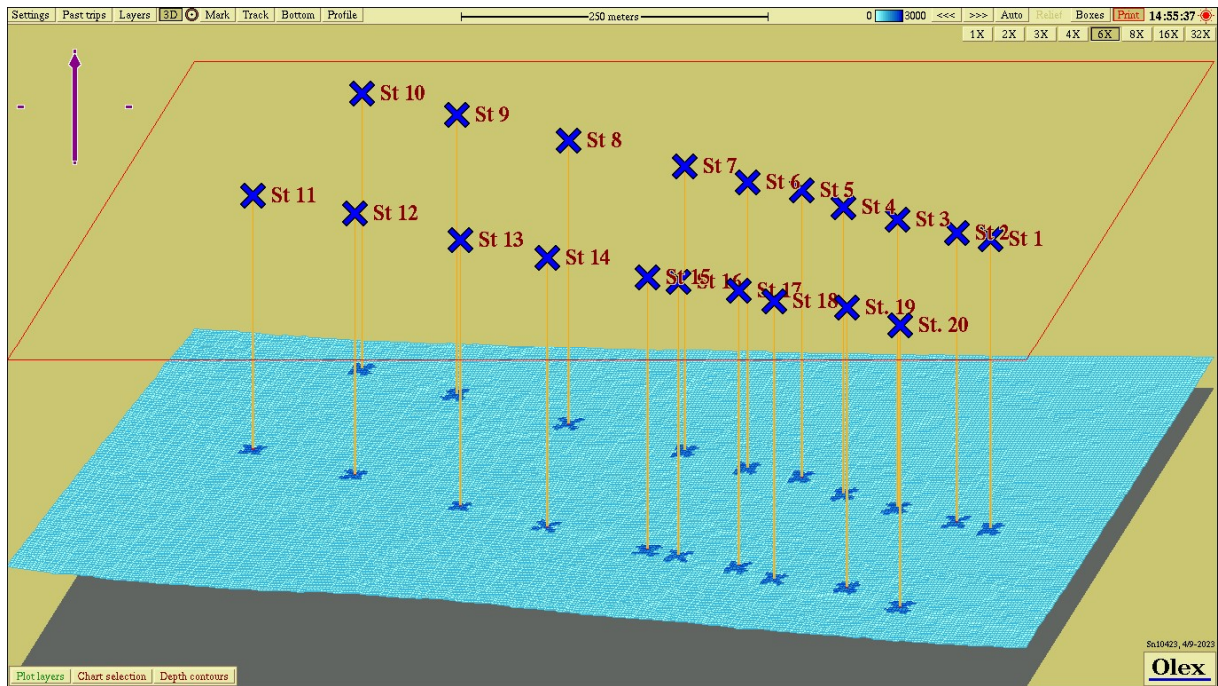
Figure 3. Bottom topography in 3D at Eyrarhlíð 2 with each sampling station according to info in Figure 2 and Table 4.
