Laugardalur, Arnarlax
B survey,
July 2022
(post fallow)

Information client			
Title	Laugardalur, Arnarlax. B survey (post fallow), July 2022		
Report number	APN-64189.B01		
Site name	Laugardalur	Coordinates site	65°39,170N 023°55,813V
County	Tálknafjarðahreppur	Municipality	Tálknafjörður
MTB-or estimated max biomass	6.414 tonnes	Site manager/contact	Silja Baldvinsdóttir
Client name	Arnarlax

Results from B-survey according to NS 9410:2016 (main results)			
Parameters and indexes		Parameters and site status	
Gr. II. pH/Eh	0,00	Gr. II. pH/Eh	1
Gr. III. Sensory	0,64	Gr. III. Sensory	1
GR. II + III	0,32	GR. II+ III	1
Date fieldwork	06.07 2022	Date report	11.10.22
Site status (NS 9410:2016):			1

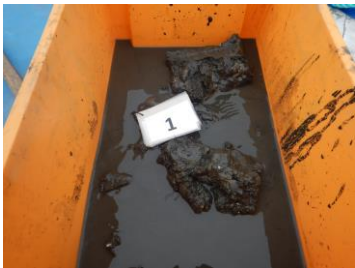
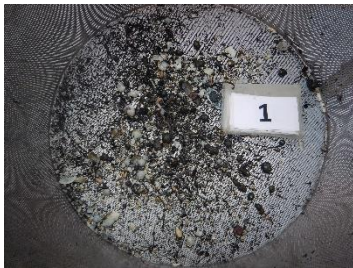
<i>St 1</i>

A photograph showing a dark, irregularly shaped sample labeled '1' resting on a black tray inside an orange container. The sample appears to be a piece of sediment or rock.

A photograph showing the same sample labeled '1' after being sieved. The material is a fine, dark, granular substance spread across a circular sieve.
<i>St 2</i>

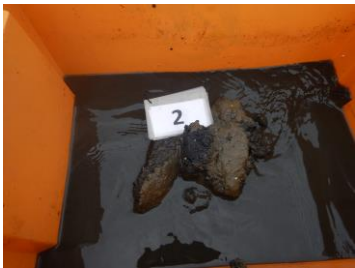
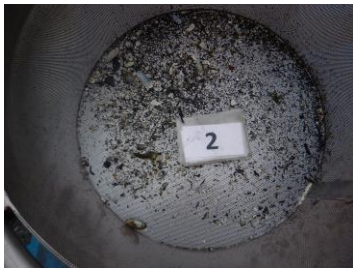
A photograph showing a dark, irregularly shaped sample labeled '2' resting on a black tray inside an orange container.

A photograph showing the same sample labeled '2' after being sieved, appearing as a fine, dark, granular substance on a circular sieve.
<i>St 3</i>

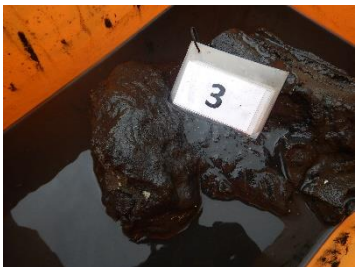
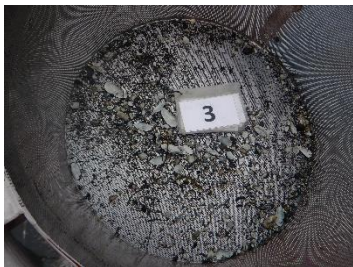
A photograph showing a dark, irregularly shaped sample labeled '3' resting on a black tray inside an orange container.

A photograph showing the same sample labeled '3' after being sieved, appearing as a fine, dark, granular substance on a circular sieve.
<i>St 4</i>

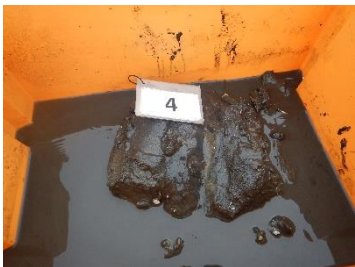
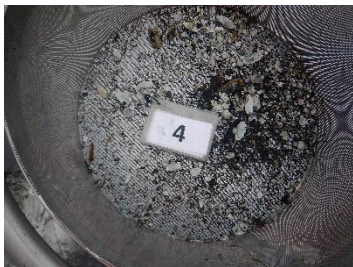
A photograph showing a dark, irregularly shaped sample labeled '4' resting on a black tray inside an orange container.

A photograph showing the same sample labeled '4' after being sieved, appearing as a fine, dark, granular substance on a circular sieve.

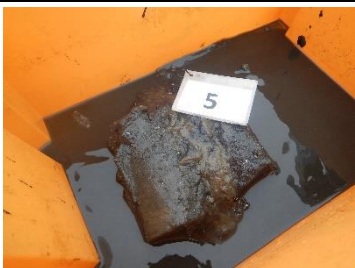
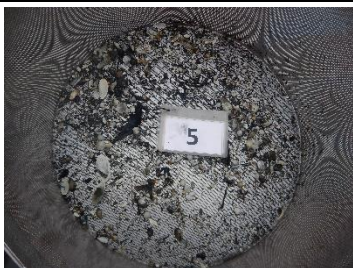
<i>St 5</i>

A photograph showing a dark, irregularly shaped sample labeled '5' resting on a black tray inside an orange container.

A photograph showing the same sample labeled '5' after being sieved, appearing as a fine, dark, granular substance on a circular sieve.
