Annual Summary Report 2017

CleanSeaNet Satellite-Based Oil Spill Detection in Icelandic Area of Interest

- and Other Pollution or Potential Pollution Related Information reported by the Icelandic Coast Guard

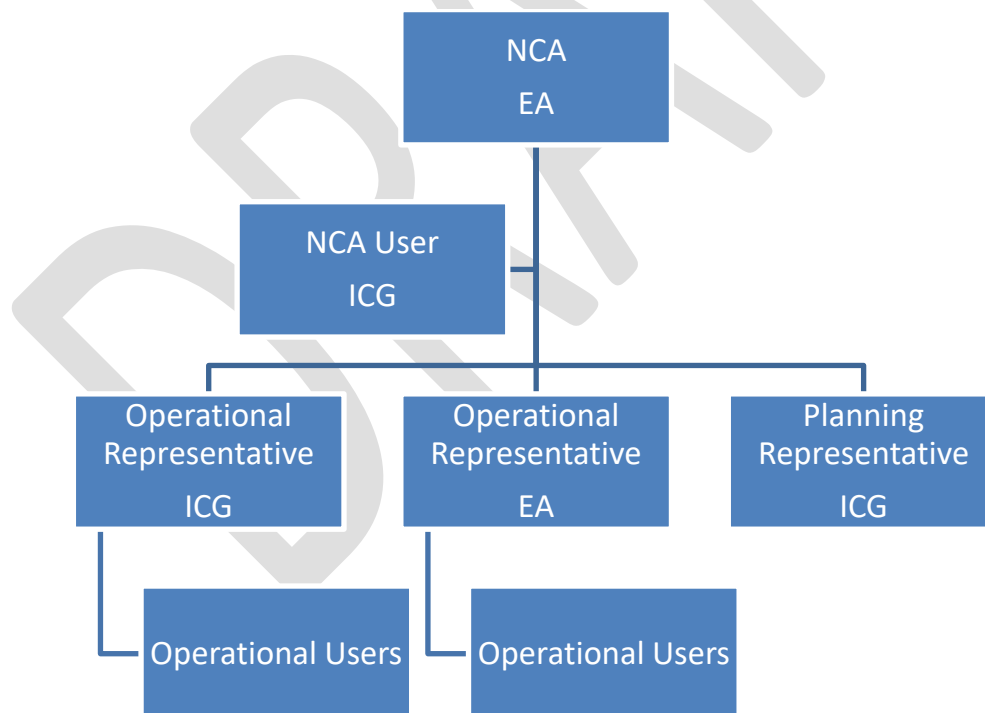
All users shall comply with the conditions of use. The structure of users in the system is shown below; EA being the Environment Agency of Iceland; ICG being the Icelandic Coast Guard. The Icelandic Coast Guard NCA User administrates the web-based system and oversees the allocation of EOS carried out by EMSA.

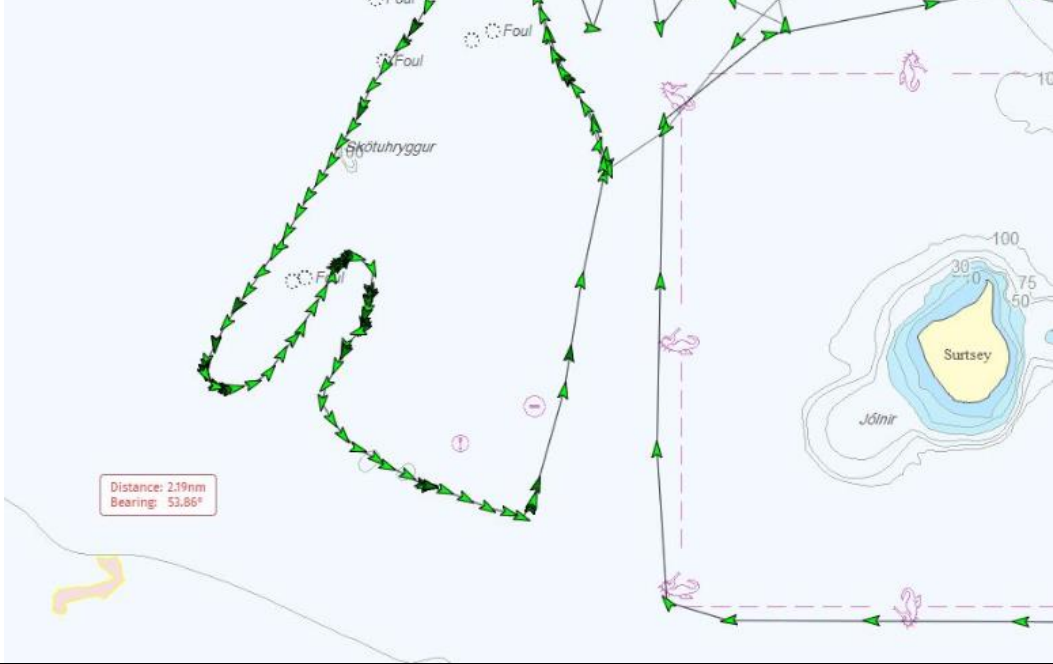
<p>Ref 28 Case 17</p>	OS_1707080002_1	B	022° 51' 13.41" W / 066° 40' 28.32" N	2017-07-08 07:57:33	<p>Fishing activity Herring</p>
<p>The image was acquired at 07:56Z. At 08:40Z, a warning of an on-going or very recent possible spill was reported and at 08:42, the notification report was received stating a class B possible oil spill.</p> <p>The pelagic fishing vessel [REDACTED] was connected to, and the track aligned with the detection.</p> <p>The vessel was contacted and crew reported that processing of its herring catch was on-going. Further that oil residues are never pumped to sea. Slop tanks were emptied at last port at Nordfjordur.</p>					
<p>Ref 29 Case 18</p>	OS_1707020001_1	A	016° 09' 01.04" W / 068° 59' 44.94" N	2017-07-02 18:36:35	<p>Fishing Investig after 15 h. by Danish vessel</p>
<p>Possible Oil Spill North of Iceland</p> <p>At 19:00Z, an oil spill warning was received from EMSA that an on-going or very recent possible oil spill (high likelihood) was reported in position 68.995816N - 16.150290W or just outside the IEEZ North of Iceland. Four Greenlandic trawlers ([REDACTED]) could be identified in the area whereas one ([REDACTED]) could be aligned with the reported possible oil spill. The Icelandic Coast Guard did not have any air or surface assets available for investigation. The Arctic Command in Greenland and the Icelandic Environment Agency were informed. An email with questions regarding any possible oil spill was sent to the possible source vessel. An email was received from the possible source vessel stating that no oil had been observed coming from the vessel. The vessel was pair trawling with another vessel ([REDACTED]), which informed that they were fileting herring which contains a lot of fish oil. At 22:13Z, the Arctic Command informed the ICG by phone that they would send a vessel to investigate with ETA after 15 hours. Next day at 19:10Z, Arctic Command informed that they had closed the investigation without finding any evidence of oil.</p>

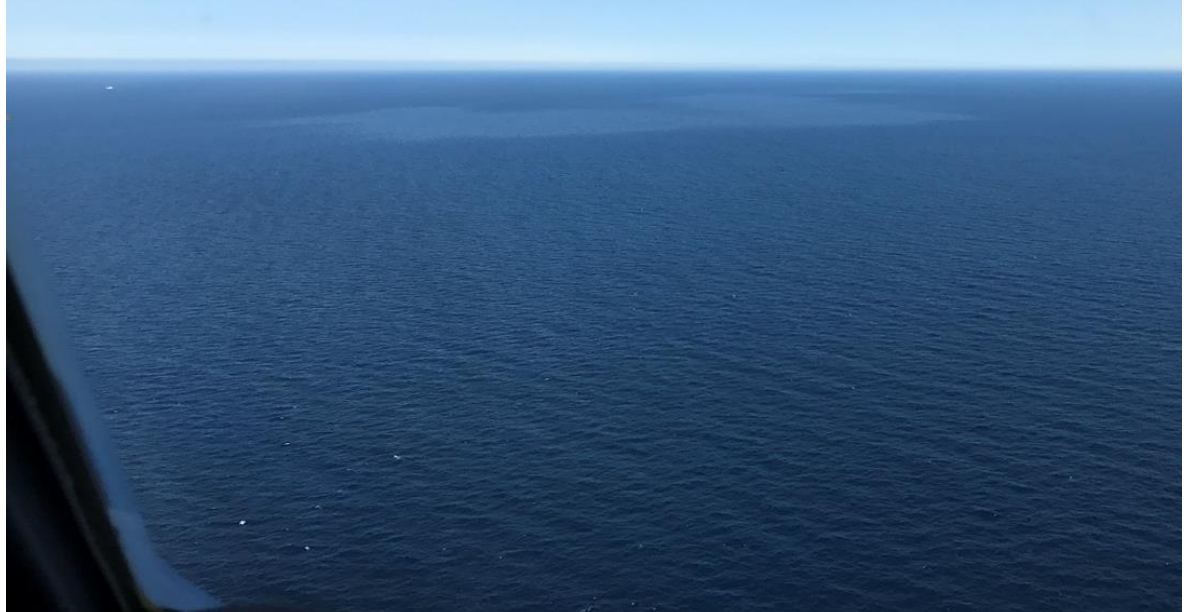
<p>Joint Arctic Command sent a fixed wing aircraft to investigate this possible oil spill just outside the Icelandic Exclusive Economic Zone. No oil spill or sheen could be observed. What they observed could more likely be related to a current front or other natural phenomena. In the CleanSeaNet GIS viewer some Greenlandic fishing vessels could be observed close to the detection.</p>
