Haukadalsbót, Arctic Sea Farm B-bottom survey fallow period, March 2020

Information client			
Title	Haukadalsbót, Arctic Sea Farm. B-bottom survey fallow period, March 2020		
Report number	APN-62024.B01		
Site name	Haukadalsbót	Coordinates site	65°53.342 N 23°35.871 V
County	Ísafjarðabær	Municipality	Þingeyri
Estimated max biomass	4000 ton	Site manager/contact	Steinunn Guðný Einarsdóttir
Client name	Arctic Sea Farm

Results from B-survey iht. NS 9410:2016 (main results)			
Parameters and indexes		Parameters and site status	
Gr. II. pH/Eh	0,00	Gr. II. pH/Eh	1
Gr. III. Sensory	0,25	Gr. III. Sensory	1
GR. II + III	0,13	GR. II+ III	1
Date field work	25.03 2020	Date report	15.04.20
Site status (NS 9410:2016):			1

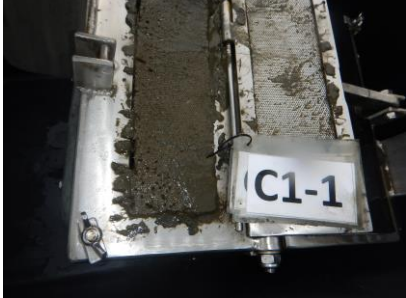
<i>St 1</i>

<p>A photograph of a sample labeled 'C1-1' in a metal tray. The sample is a dark, granular material, possibly sediment or organic matter, resting on a light-colored surface within the tray.</p>

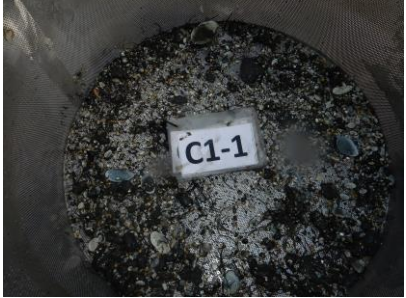
<p>A photograph of the same sample labeled 'C1-1' after being passed through a sieve. The material is now a fine, dark, granular residue spread across the sieve's mesh.</p>
<i>St 2</i>

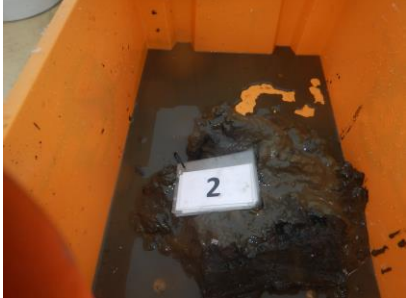
<p>A photograph of a sample labeled '2' in an orange tray. The sample is a dark, irregular mass of material, possibly sediment or organic matter, resting on a dark surface within the tray.</p>

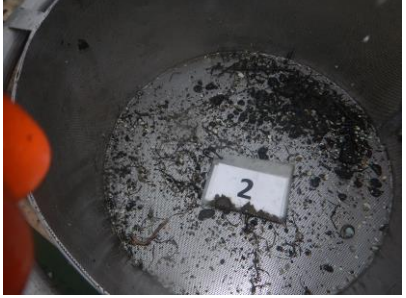
<p>A photograph of the same sample labeled '2' after being passed through a sieve. The material is a dark, granular residue spread across the sieve's mesh.</p>
<i>St 3</i>

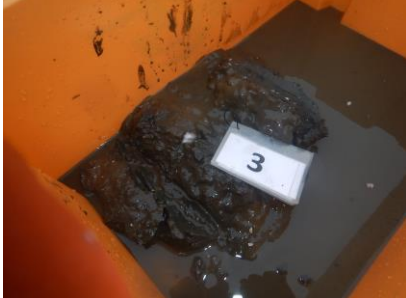
<p>A photograph of a sample labeled '3' in an orange tray. The sample is a dark, irregular mass of material, possibly sediment or organic matter, resting on a dark surface within the tray.</p>

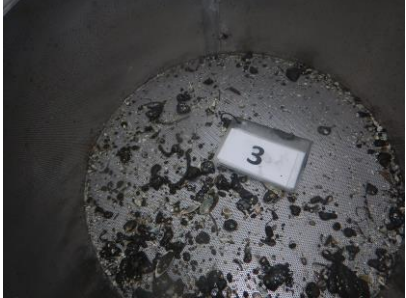
<p>A photograph of the same sample labeled '3' after being passed through a sieve. The material is a dark, granular residue spread across the sieve's mesh.</p>

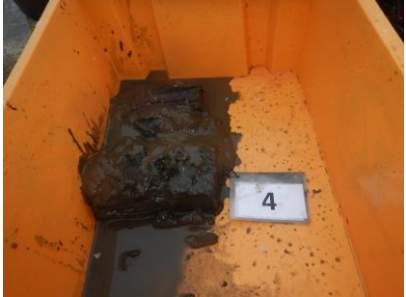
<i>St 4</i>

<p>A photograph of a sample labeled '4' in an orange tray. The sample is a dark, irregular mass of material, possibly sediment or organic matter, resting on a dark surface within the tray.</p>

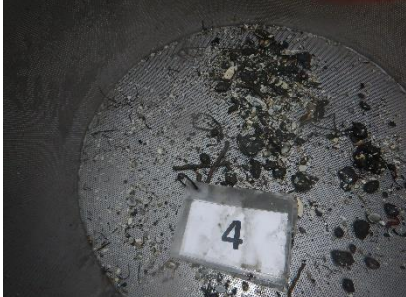
<p>A photograph of the same sample labeled '4' after being passed through a sieve. The material is a dark, granular residue spread across the sieve's mesh.</p>
<i>St 5</i>

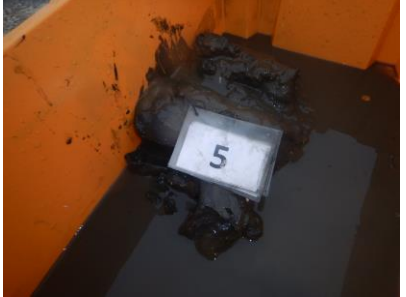
<p>A photograph of a sample labeled '5' in an orange tray. The sample is a dark, irregular mass of material, possibly sediment or organic matter, resting on a dark surface within the tray.</p>

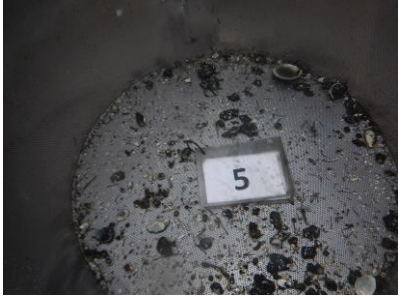
<p>A photograph of the same sample labeled '5' after being passed through a sieve. The material is a dark, granular residue spread across the sieve's mesh.</p>
