Information client			
Title	Eyrarhlíð, Arctic Sea Farm. B-bottom survey, April 2021		
Report number	APN-63090.B01		
Site name	Eyrarhlíð	Coordinates site	65°54.898 N 023°40.390 V
County	Ísafjarðarbær	Municipality	Ísafjarðarbær
MTB-or estimated max biomass	5.779 ton	Site manager/contact	Steinunn Guðný Einarsdóttir
Client name	Arctic Sea Farm

Results from B-survey iht. NS 9410:2016 (main results)			
Parameters and indexes		Parameters and site status	
Gr. II. pH/Eh	0,24	Gr. II. pH/Eh	1
Gr. III. Sensory	0,82	Gr. III. Sensory	1
GR. II + III	0,53	GR. II+ III	1
Date field work	15.04 2021	Date report	22.09.21
Site status (NS 9410:2016):			1

The sampling date for the present site survey was 15.04 2021 and done by Akvaplan-niva AS contracted by Arctic Sea Farm in relation to the company's fish farming activity at the site Eyrarhlíð in Dýrafjörður, Ísafjarðabær municipality.

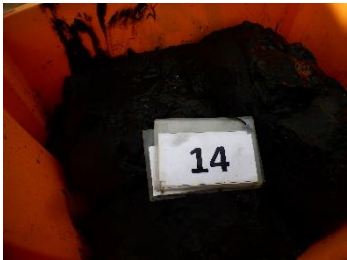
<p><i>St 14</i></p>

For combined parameters II and III (pH/redox and sensory) fifteen stations had status 1 «very good» and two stations had condition 2 «good». The stations with status 2 (stations 11 and 14) at the western part of the fish farming area. The accumulation of organic material seems therefore to a greater extent to accumulate at the eastern part of the fish farming area. The dominating current (39 m) is in direction south-east (130 degrees) with a smaller counter current in north-west direction. The apparent higher accumulation of organic material on the western edge i.e. in opposite direction of the spread current could also be associated to that the cages on the western part of the site were the ones that fish for the longest time prior to slaughter. Animals were present in all soft bottom samples. The previous B bottom survey (at halv max and max biomass) gave also overall condition 1 «very good». The results for the current B-survey at fallow indicate some moderate organic load in small part of the site but in general the condition is in line with previous surveys indicating overall very good condition in the local impact zone.
