Gemlufall, Arctic Sea Farm hf.  
B-bottom survey,  
May 2020  
(Post fallow period)

Information client			
Title	Gemlufall, Arctic Sea Farm hf. B-bottom, May 2020		
Report number	APN-62175.B01		
Site name	Gemlufall	Coordinates site	65°53.151 N 023°28.295 V
County	Ísafjarðarsýsla	Municipality	Ísafjarðarbær
MTB-or estimated max biomass	3500 tonn	Site manager/contact	Steinunn G. Einarsdóttir
Client name	Arctic Sea Farm hf.

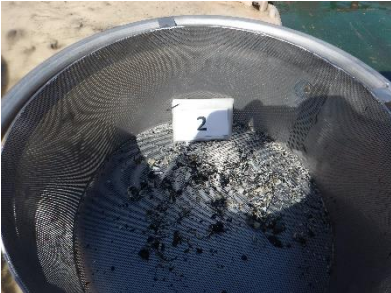
<p><i>St 2</i></p>

<p>N/A</p>
