Kvígindisdalur, Arctic Sea Farm
B-bottom survey,
September 2021
(fallow period)

Information client			
Title	Kvígingisdalur, Arctic Sea Farm. B-bottom survey, September 2021		
Report number	APN-63430.02		
Site name	Kvígingisdalur	Coordinates site	65°34.665 N 24°02.222 V
County	Vesturbyggð	Municipality	Patreksfjörður
MTB-or estimated max biomass	4.300 ton	Site manager/contact	Steinunn Guðný Einarsdóttir
Client name	Arctic Sea Farm

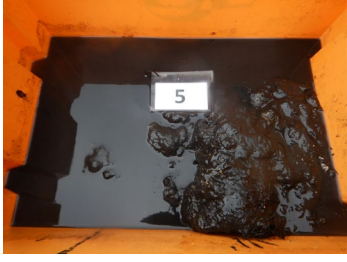
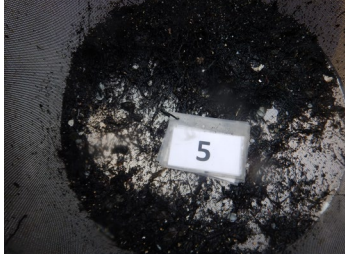
<p><i>St 5</i></p>

For combined parameters II and III (pH/redox and sensory) fourteen stations had status 1 «very good» and one station had condition 2 «good». The station with status 2 (sampling station 5) is placed at the south end of the eastern frame at the fish farming area. These results indicate in general very good status of the bottom sediment at the local impact zone estimated according to methodology in NS 9410:2016 but it can be detected that there is some organic load in the local impact zone especially at the eastern part of the site.

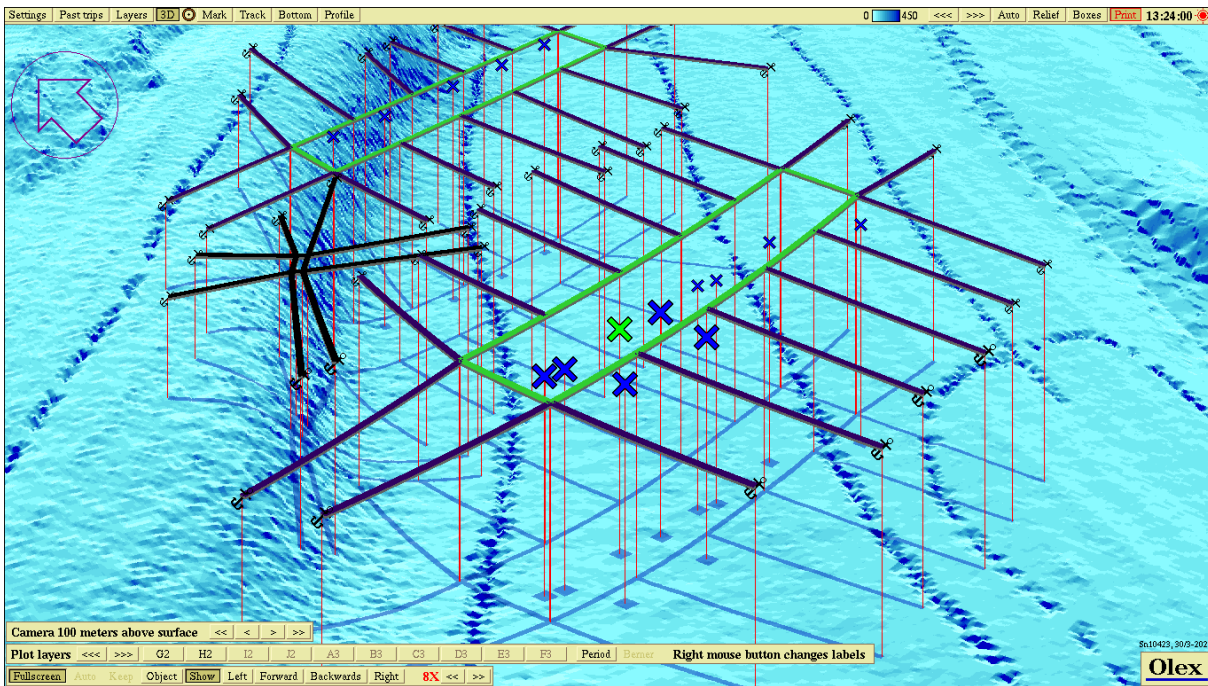
Figure 3. Showing bottom topography 3D at Kvígingisdalur with each sampling station according to info in figure 2 and Table 3.
