## Tjaldanes, Arnarlax B-bottom survey (fallow period), June 2021

Information client			
Title	Tjaldanes, Arnarlax. B-bottom survey (fallow period), June 2021		
Report number	APN-63266.B01		
Site name	Tjaldanes	Coordinates site	65°54.060 N 023°32.995 V
County	Ísafjarðarbær	Municipality	Ísafjarðarbær
MTB-or estimated max biomass	5.681 ton	Site manager/contact	Silja Baldvinsdóttir
Client name	Arnarlax

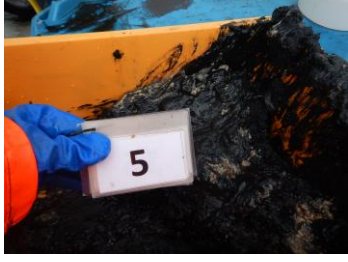
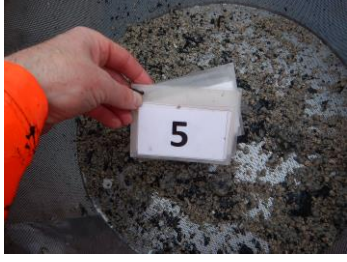
<p><i>St 5</i></p>

Sample number	1	2	3	4	5	6	7	8	9	10
Depth (m)	100	89	102	102	104	104	99	98	92	83
Number of trials	1	1	1	1	1	1	1	1	1	1
Gas bubbles (in sample)	No	No	No	No	Yes	Yes	No	No	No	No
Sediment type	Clay	X	X	X	X	X	X	X	X	X
	Silt									
	Sand									
	Gravel								X	
	Shellsand									
Reef										
Rocky bottom (cobbles, boulders)										
Echinodermata, count										
Crustaceans, count			1			1				
Molluscs, count										
Polychaetes, count	<50	<50	3	2		2	<50	<100	<20	<100
Other animals, count										
<i>Beggiatoa</i>										
Feed					X					
Faeces										
Comments	Lots of feed in grab sample at station 5									
Grab	Area [m <sup>2</sup> ]	0,1			Grab ID	K-3				
	page 3 of 4 pages
