MEMO		
Project number 3848-017	Customer Becromal Iceland ehf	Date 15.02.2016
Project Noise measurements		
Subject Noise measurements on the Becromal production site		
Sender Kristín Ómarsdóttir, EFLA hf.		
Receiver Urszula Tlolka, Becromal Iceland ehf.

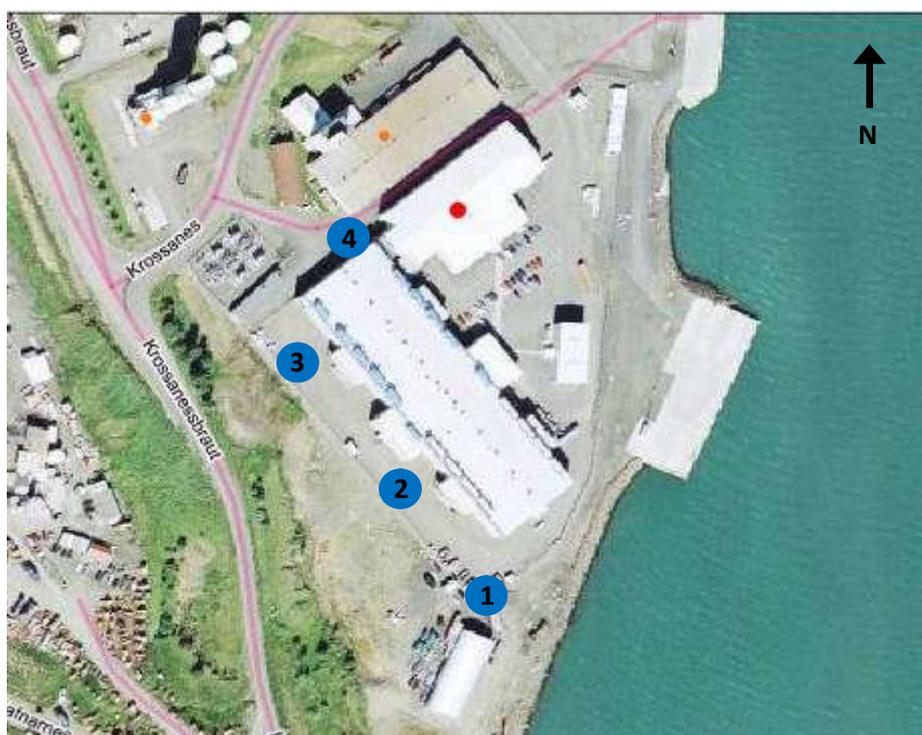
The sound level meter was set up in four different places, on two locations on the south-west side of the building, one location at the south-west boundary and on one location on the north-west boundary of the Becromal production site. Both the noise sources and the weather conditions were very steady, so the duration used for each measurement was around 5 min., with the microphone placed 1,5 m above ground. No noise events were observed that were not related to the Becromal factory operation. The measuring locations are marked with numbered blue circles in figure 1.

Figure 1: Four different measurement locations on the Becromal production site.

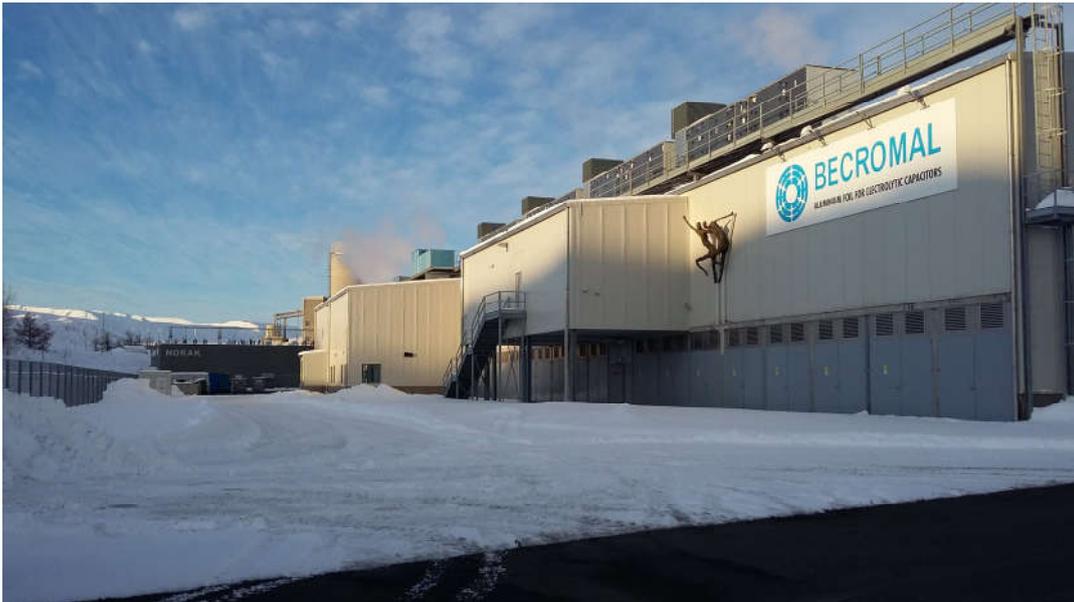
The first measurement location was at the south corner of the plot. The noise from the Becromal factory was dominant and no activity unrelated to the factory could be heard.

Figure 2: First measurement location.

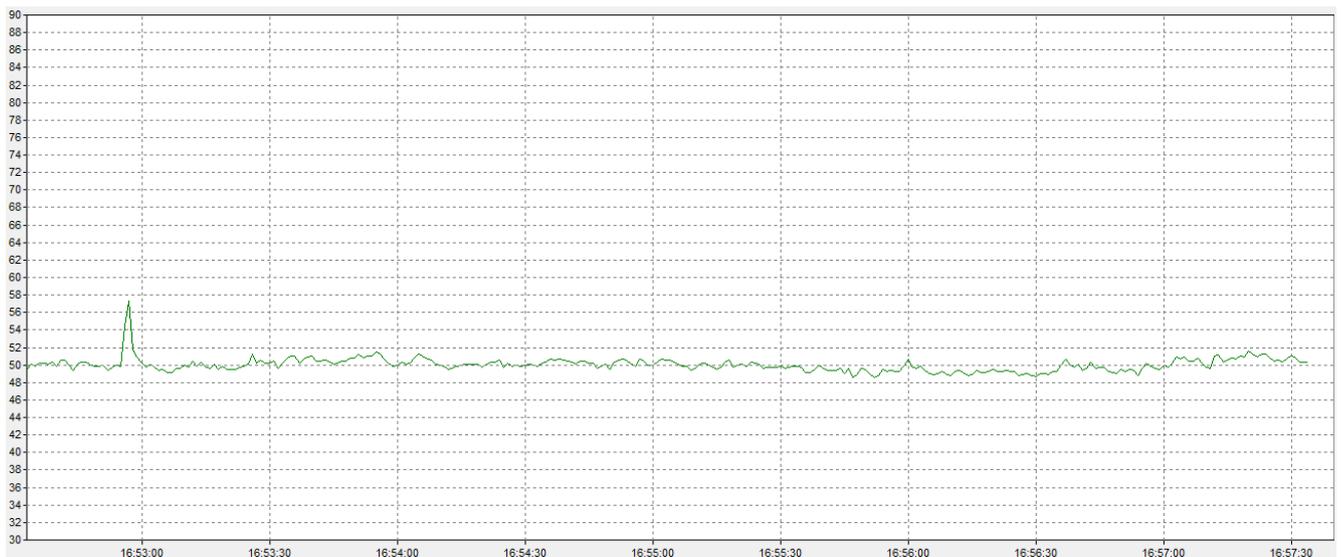
Figure 3: Measurement location 1. Equivalent sound level [dB(A)] as a function of time.

The noise level is quite steady in all locations, as can be seen on figures 3, 6, 9 and 12. It can be assumed that noise from wind had very little effect on the measurement results. The equivalent sound level was measured below $L_{eq} = 70$ dB(A) in all locations. The noise level of $L_{eq} = 50$ dB(A) on the south-west corner of the production site indicates that the noise level in the residential area will also be below regulation limits.

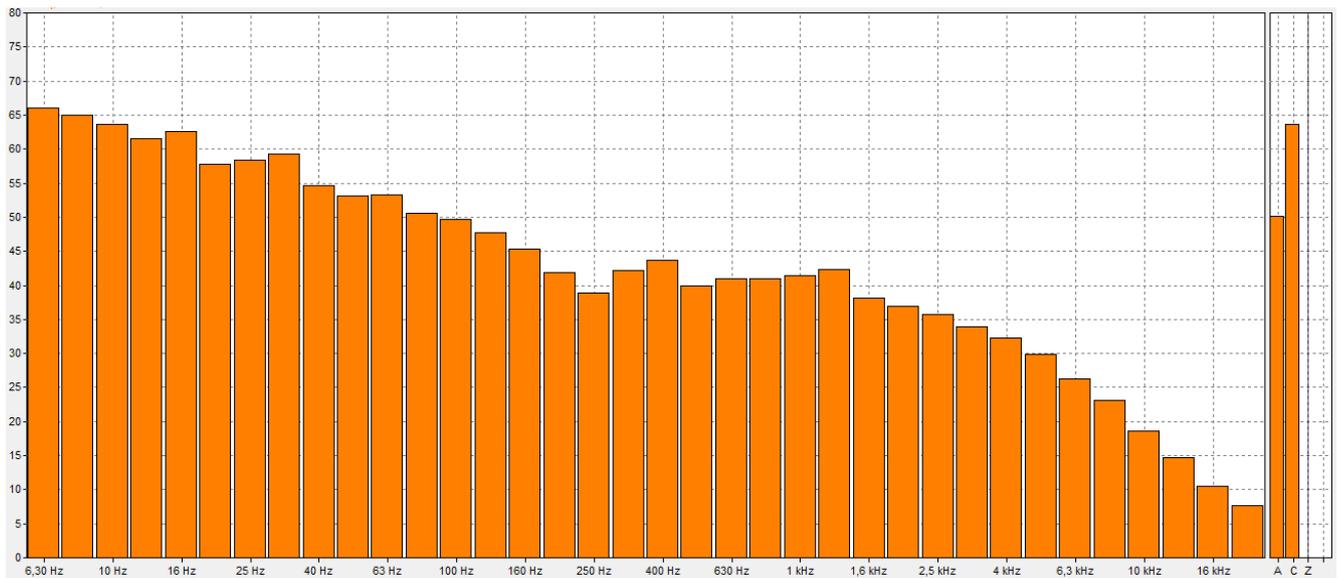
Figure 4: Measurement location 1. Equivalent sound level [dB(A)] as a function of frequency.

The effect of the wind was negligible. The noise source is quite steady, but was positioned downwind from the microphone. Low frequencies are dominant in the measured noise level in this location, as can be seen in figure 4.

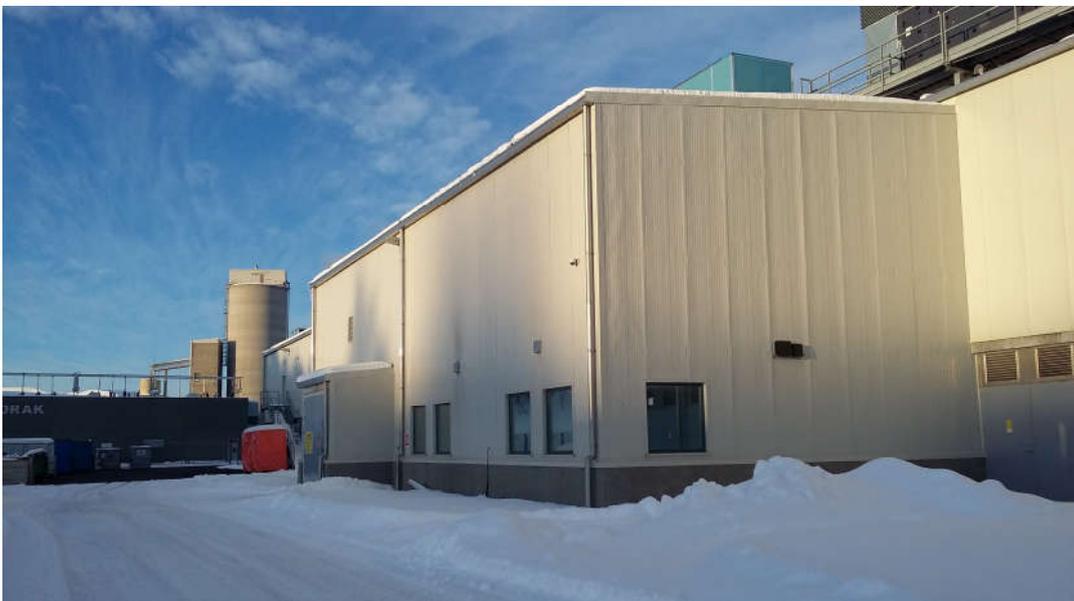
The second location can be seen in figure 5. The noise from the Becromal factory was dominant and no activity unrelated to the factory could be heard.

Figure 5: Second measurement location.

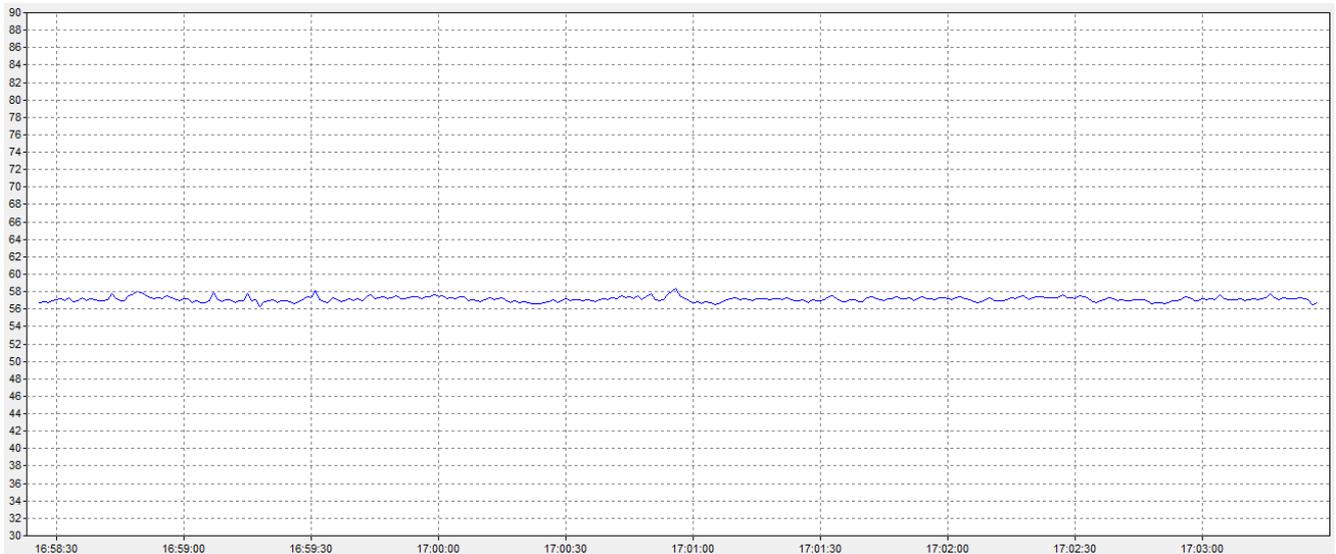
Figure 6: Measurement location 2. Equivalent sound level [dB(A)] as a function of time.

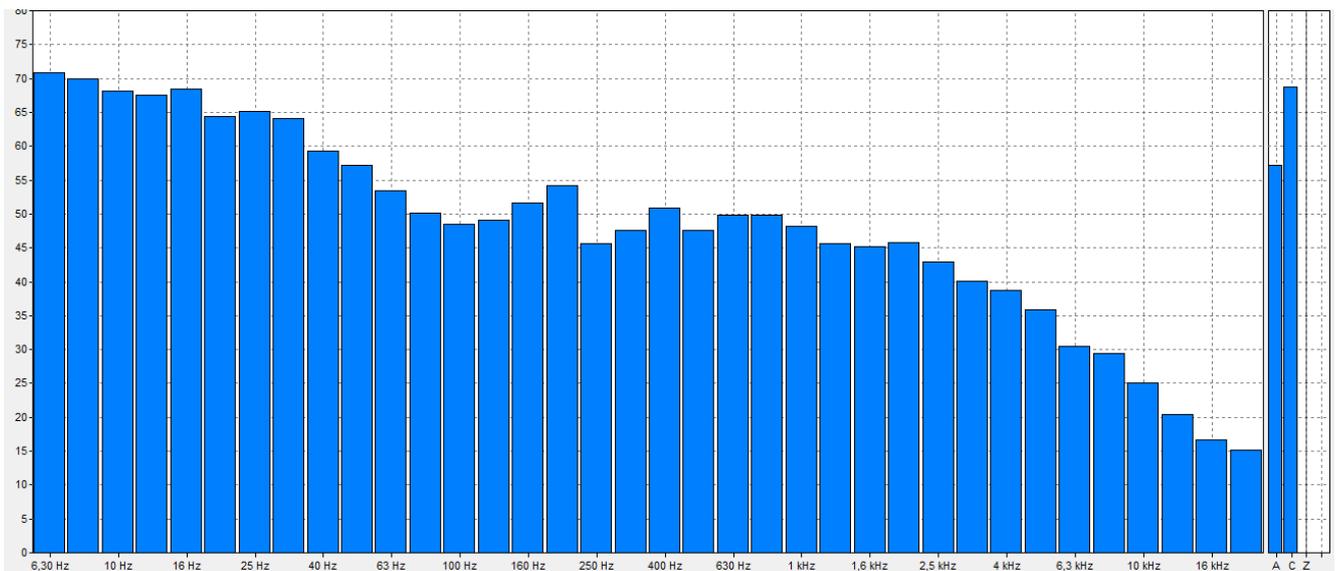
Figure 7: Measurement location 2. Equivalent sound level [dB(A)] as a function of frequency.

The effect of the wind was negligible. The noise source is quite steady. Low to mid frequencies are dominant in the measured noise level in this location, as can be seen in figure 4.

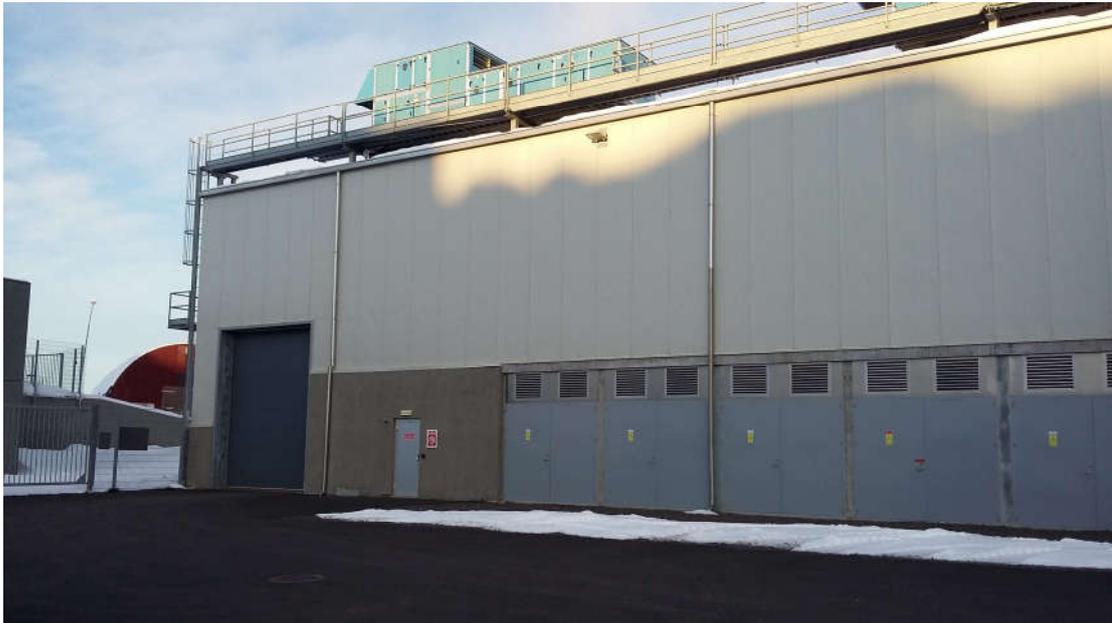
On the third location, there was an audible tonal frequency. The frequency spectrum was measured in 1/3 octaves, which showed tonal frequencies at around 160-200 Hz and 315 Hz. The noise from the Becromal factory was dominant and no activity unrelated to the factory could be heard. In the middle of the measurement there was a forklift dumping waste into a container near the measurement equipment, which can be seen on figure 9.

Figure 8: Third measurement location.

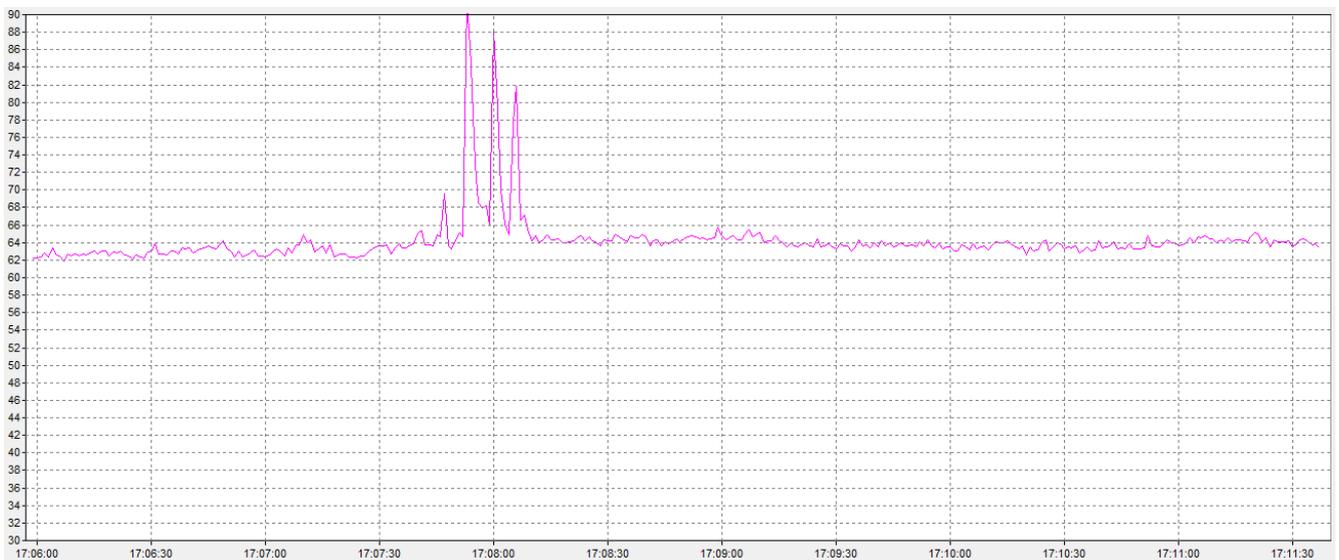
Figure 9: Measurement location 3. Equivalent sound level [dB(A)] as a function of time.

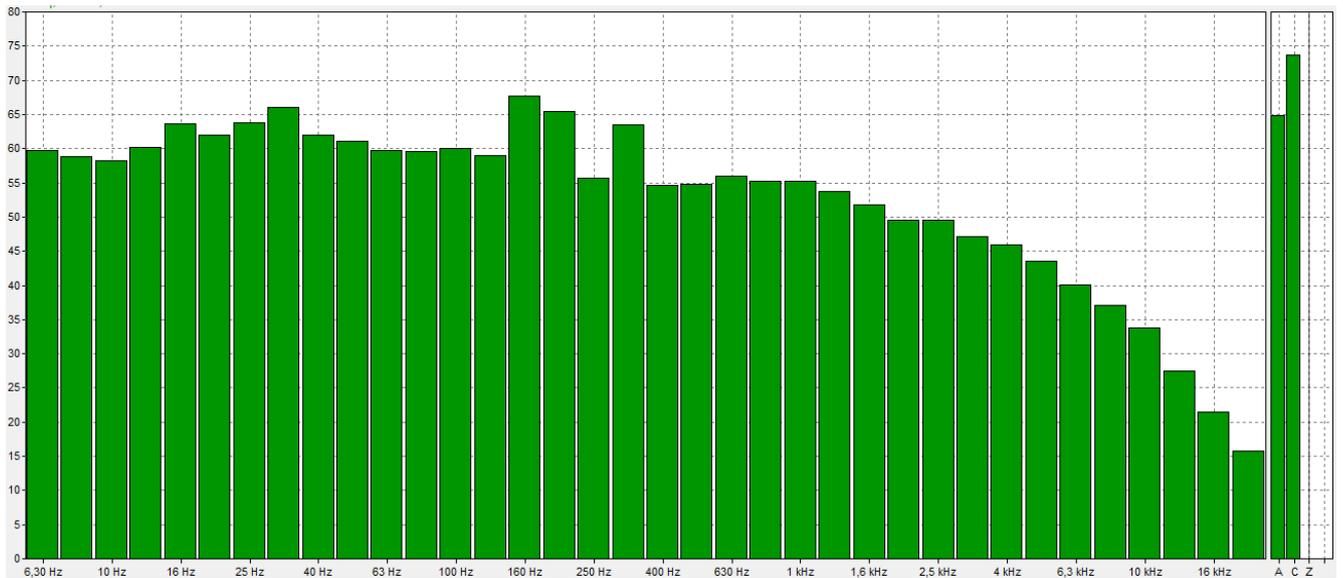
Figure 10: Measurement location 3. Equivalent sound level [dB(A)] as a function of frequency.

The effect of the wind was negligible. The noise source is quite steady. Low to mid frequencies are dominant in the measured noise level in this location, as can be seen in figure 10.

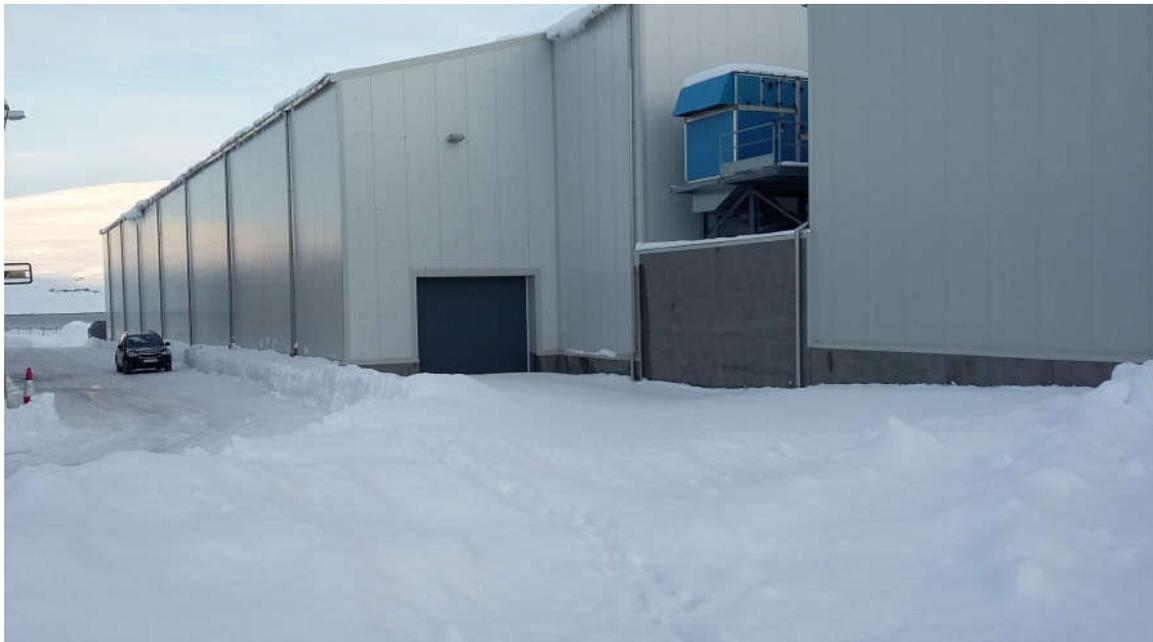
The fourth location was downwind from the Becromal factory. The dominating noise source was the Becromal factory.

Figure 11: Microphone positioned in location 3.

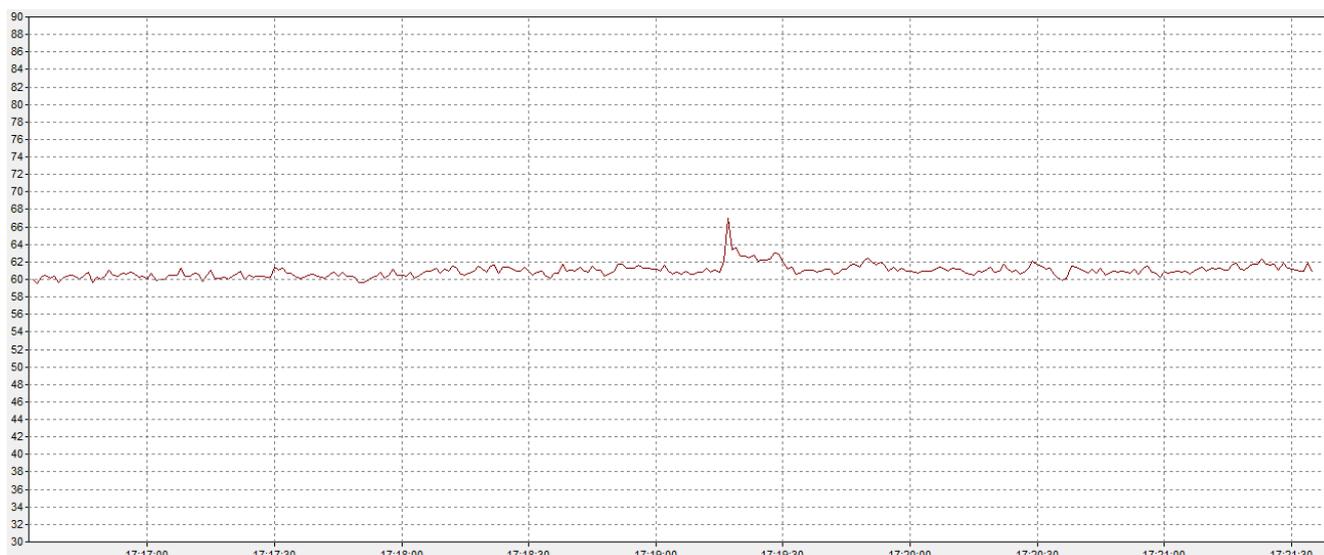
Figure 12: Measurement location 4. Equivalent sound level [dB(A)] as a function of time.

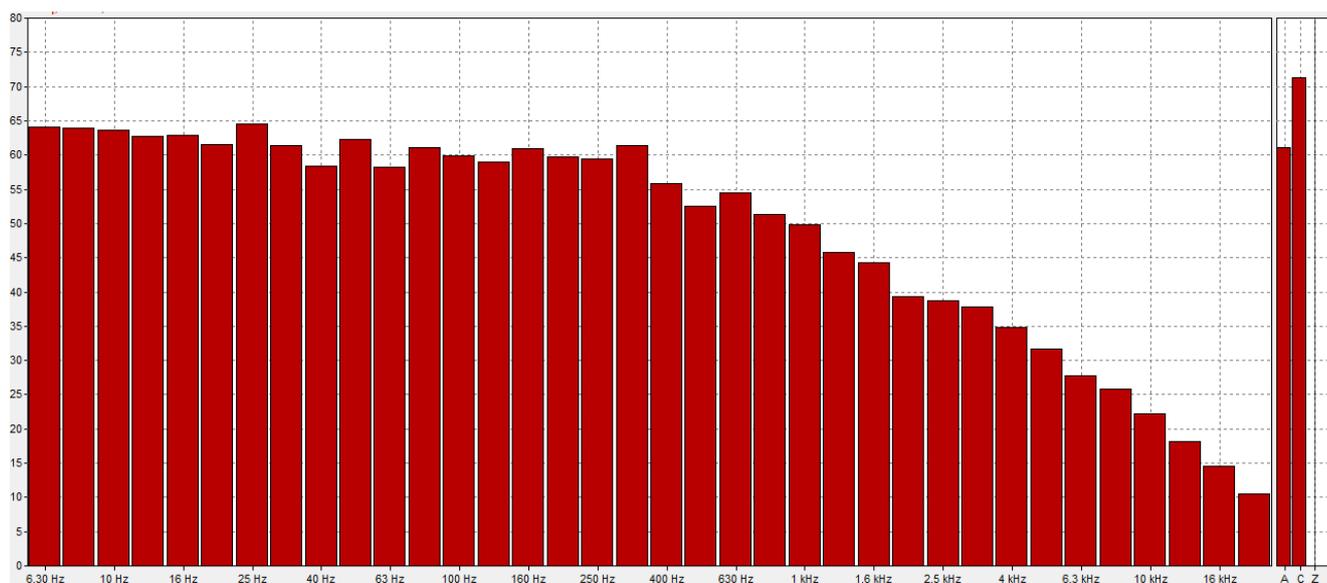
Figure 13: Measurement location 4. Equivalent sound level [dB(A)] as a function of frequency.

Low frequencies are dominant in the measured noise level in this location, as can be seen in figure 13.
