# Annual Marine Oil Pollution Report for the year 2022

- CleanSeaNet Satellite-Based Oil Spill Detection inside Icelandic Exclusive Economic Zone and Other Pollution or Potential Pollution Related Information Reported by the Icelandic Coast Guard

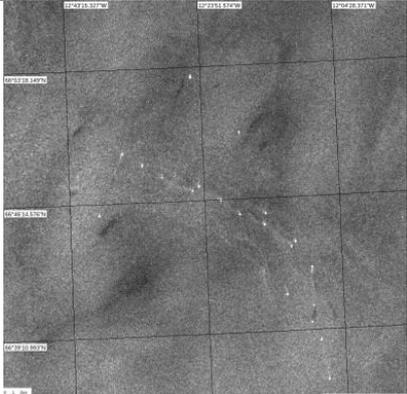
OS	Acquisition Start	Lat (Center)	Long (Center)	Area (km2)	# of slicks	Class	Comments
1	2022-01-23 07:26:32Z	67°54.09'N	010°30.6'W	5.525654	1	B	<b>Reason for no verification:</b> Considered as a lookalike
2	2022-01-30 07:18:20Z	66°46.99'N	012°26.32'W	3.121083	6	B	<b>Reason for no verification:</b> Considered as a lookalike. Capelin fisheries.

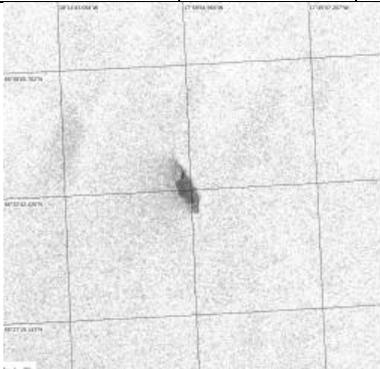
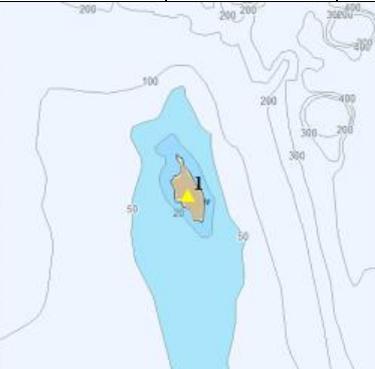
3	2022-02-17 08:07:15Z	66°32.71'N	018°00.22'W	3.979488	1	B	<b>Reason for no verification:</b> Considered as a lookalike. The island of Grimsey.

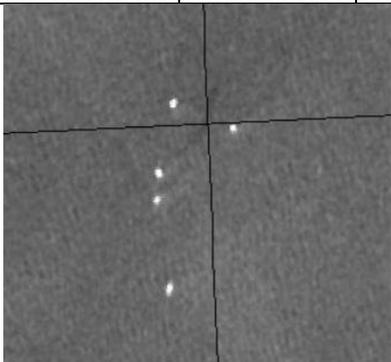
4	2022-02-26 07:42:47Z	66°44.94'N	018°19.39'W	0.238629	1	B	<b>Reason for no verification:</b> Considered as a lookalike. 5 vessels fishing for coalfish, which has fed on capelin.

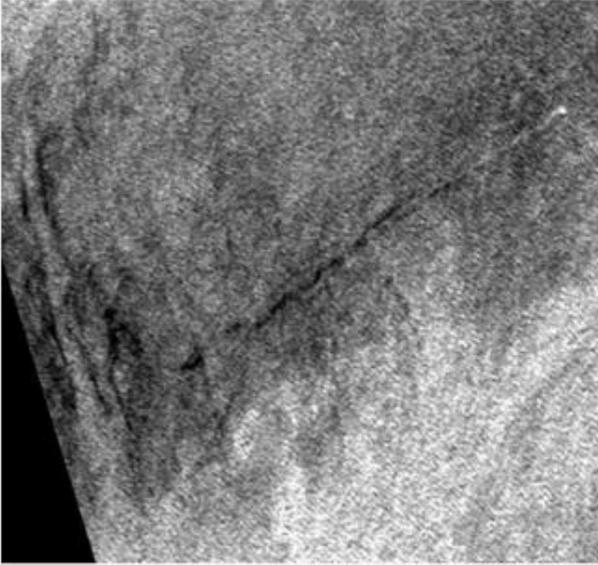
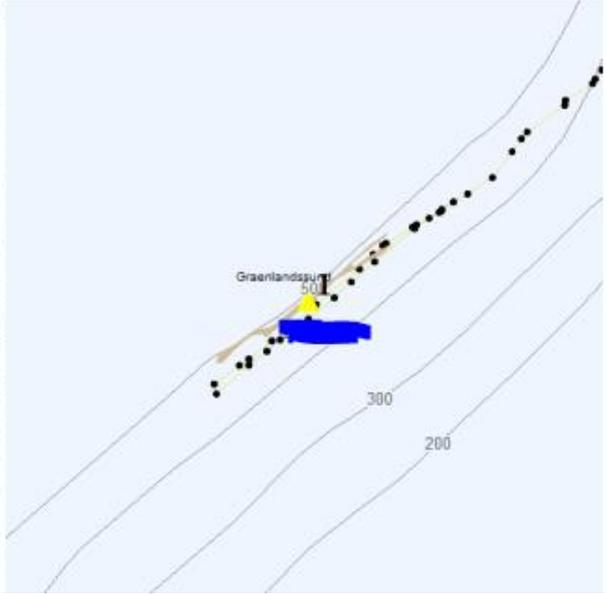
in area.
22	2022-07-03 18:52:02Z	66°55.66'N	023°06.88'W	0.058317	1	B	<b>Reason for no verification:</b> Considered a lookalike. A fishing vessel was identified as the possible source, which informed it had been taking the trawl containing coalfish and Greenland halibut. No oil pollution was reported.
<p>Contains modified Copernicus Sentinel data 2022, processed by KSAT.</p>							
23	2022-07-05 18:34:37Z	63°35.2'N	016°45.4'W	0.336522	1	B	<b>Reason for no verification:</b> Considered a lookalike. A fishing vessel, connected to the detection, checked if any oil could have come from the vessel, which was not the case. All winches on board were electric.
<p>Contains modified Copernicus Sentinel data 2022, processed by KSAT.</p>							
24	2022-07-08	66°35.67'N	025°09.39'W	2.036875	1	B	<b>Reason for no</b>

19:00:11Z						<b>verification:</b> Considered a lookalike. A fishing vessel, connected to the detection, checked if any oil could have come from the vessel, which was not the case.

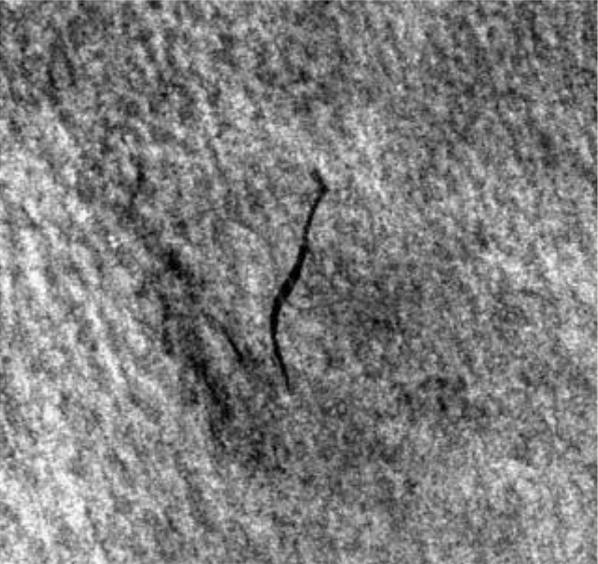
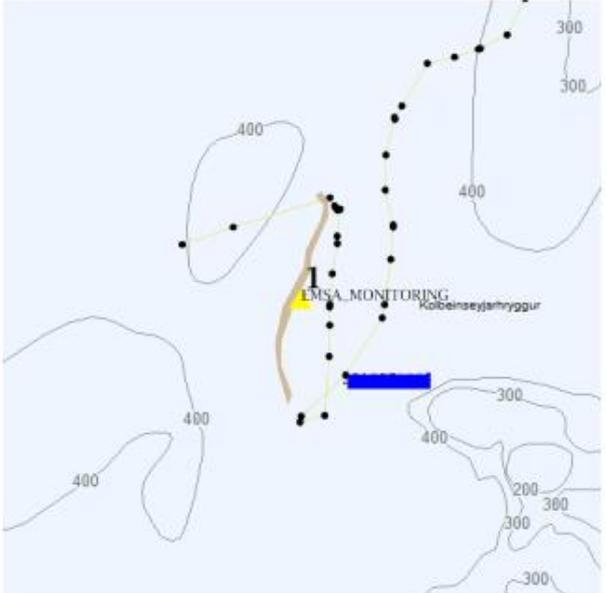
25	2022-07-17 18:35:45Z	67°33.89'N	018°50.07'W	2.687633	1	B	<b>Reason for no verification:</b> Considered a lookalike. A fishing vessel, connected to the detection, checked if any oil could have come from the vessel, which was not the case. The vessel had been processing the catch of Greenland halibut.

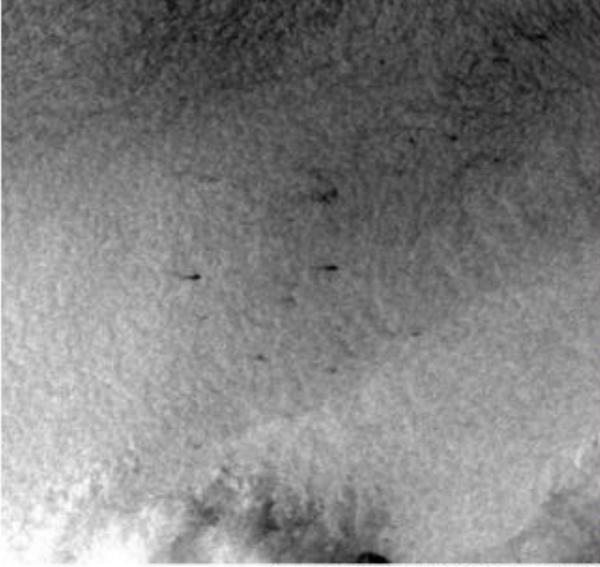
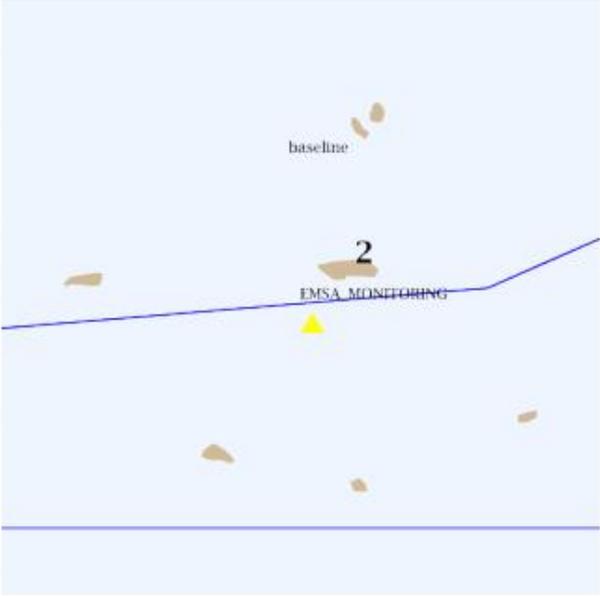
18:58:56Z						<b>verification:</b> Considered a lookalike. Natural phenomenon.
27	2022-08-01 18:58:15Z	60°05.29'N	018°04.44'W	4.131446	7	B	<b>Reason for no verification:</b> Considered a lookalike. Institute of Earth Sciences of the University of Iceland commented that the pattern looked like the source could be at the bottom of the sea.

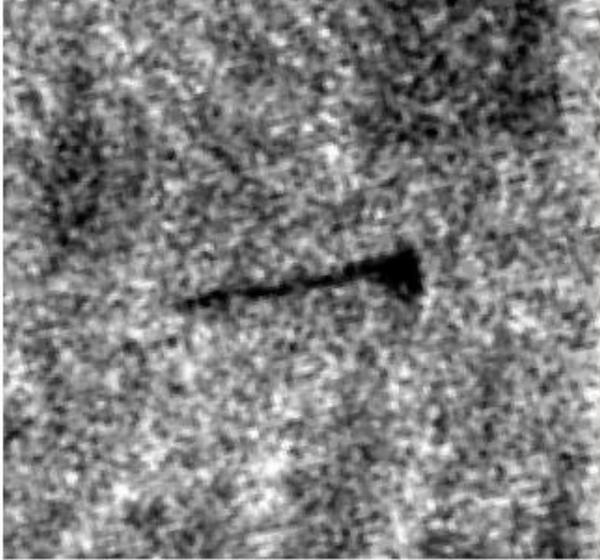
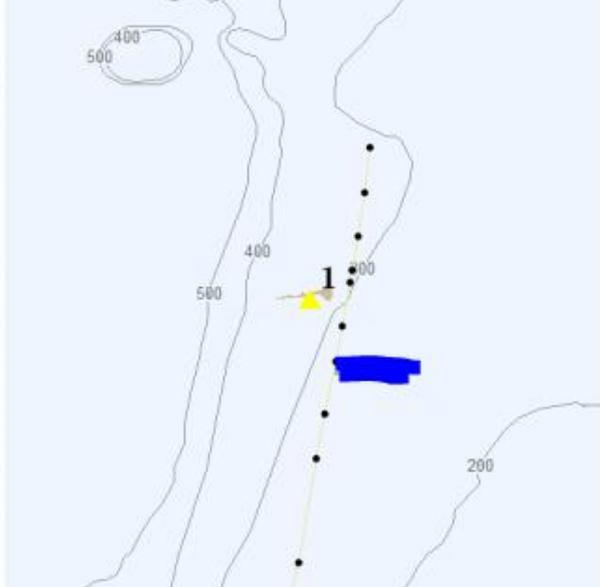
<small>Data and Products © STECOPROUD, INSTITUTE OF EARTH SCIENCES OF THE UNIVERSITY OF ICELAND AND ASSOCIATES LTD 2022 - All Rights Reserved EMSA/KSAT is an official track of the Columbus Space Agency</small>					
29	2022-08-08 18:51:55Z	66°44.53'N	018°33.91'W	0.460306	1	B	<b>Reason for no verification:</b> Considered a

<p>lookalike. The aligned fishing vessel had discharged water from the hold while underway. The detection is assessed to stem from fishing activity.</p>

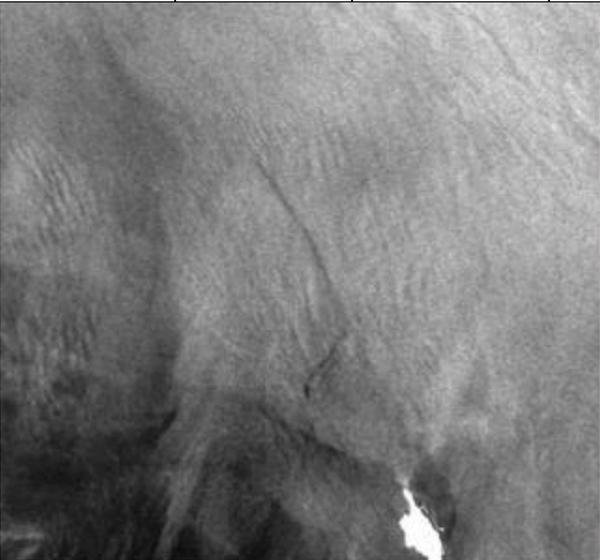
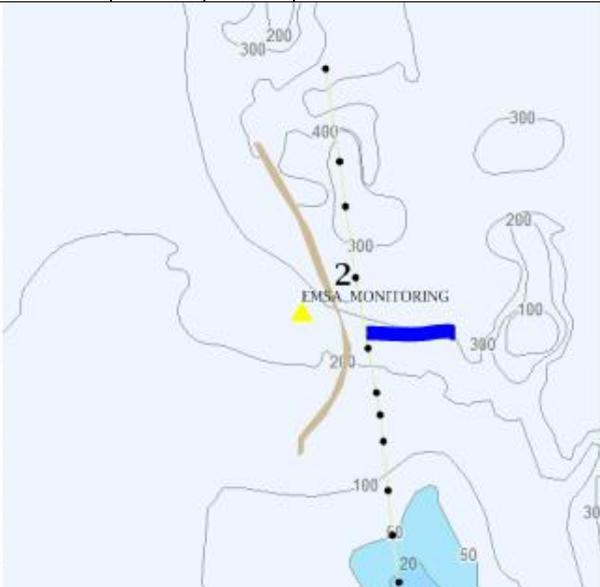
<p>Contains modified Copernicus Sentinel data 2022, processed by KSAT.</p>				
30	2022-08-08 18:51:53Z	66°40.7'N	018°07.9'W	4.122014	1	B	<p><b>Reason for no verification:</b> Considered a lookalike. The aligned fishing vessel stated that nothing was leaking or had been discharged from the vessel.</p>

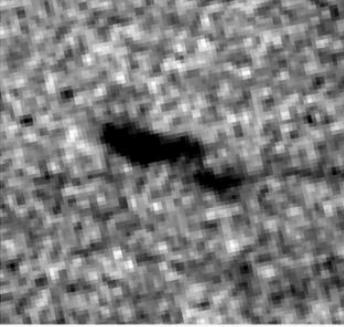
33	2022-08-13 18:58:21Z	60°15.54'N	018°39'W	0.387395	2	B	<b>Reason for no verification:</b> Considered a lookalike. No vessels in area.

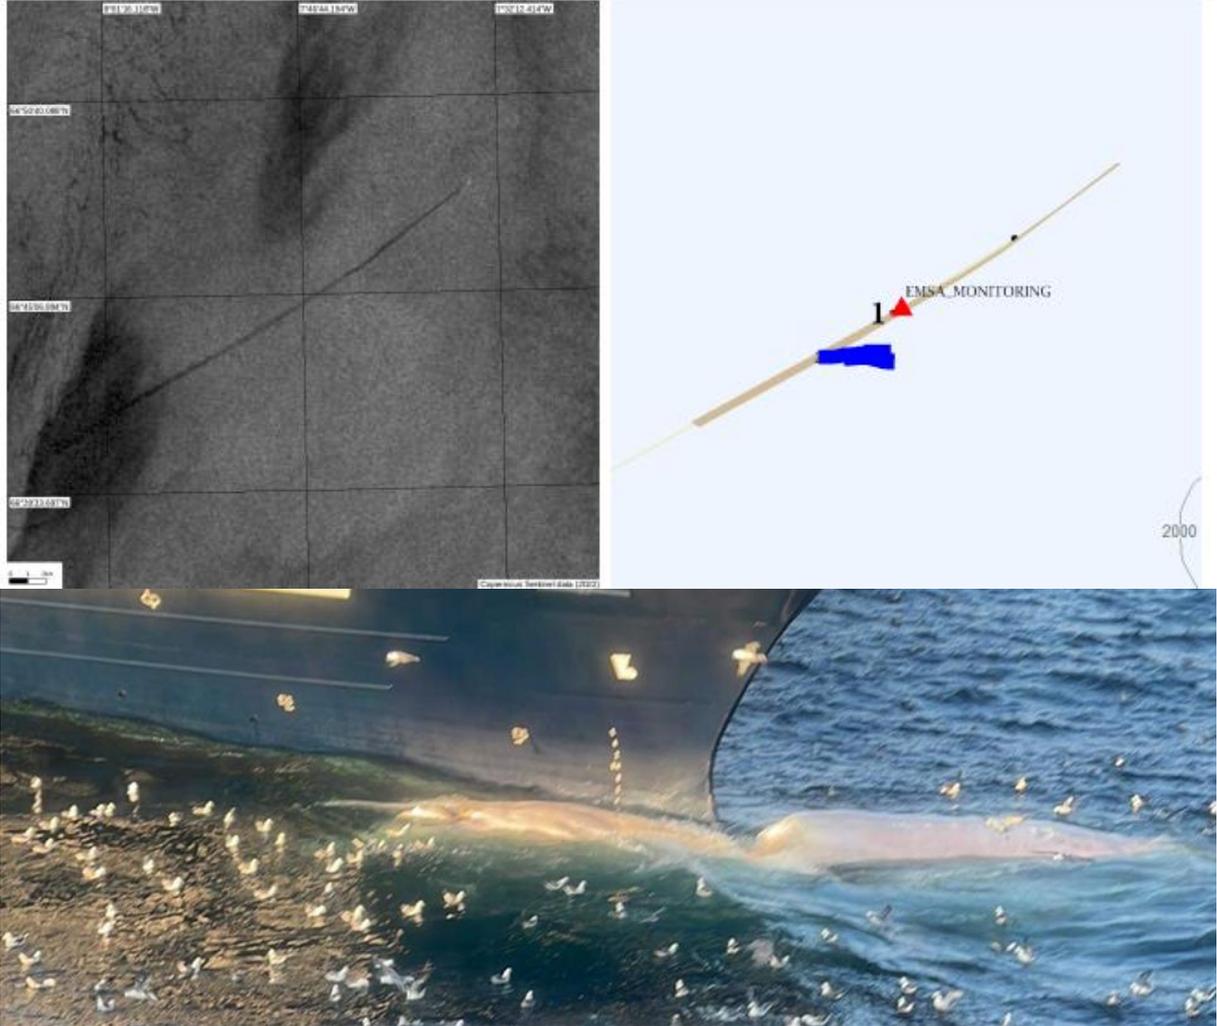
34	2022-08-14 18:03:28Z	66°39.01'N	013°14.7'W	3.843445	1	B	<b>Reason for no verification:</b> Considered a lookalike and no assets available.	
35	2022-08-14 18:03:28Z	65°45.11'N	008°59.15'W	2.290673	1	B	<b>Reason for no verification:</b> Considered a lookalike and no assets available.	
36	2022-08-15 07:26:37Z	66°45.81'N	007°43.41'W	5.496343	1	A	<b>Reason for no verification:</b> Considered a lookalike. A month later, the vessel connected to the detected possible oil spill sent a picture and explanation to the course of the detection. The vessel had collided with a whale, which had gotten stuck on the bulb. Oil from the whale is

assessed as the most possible course.

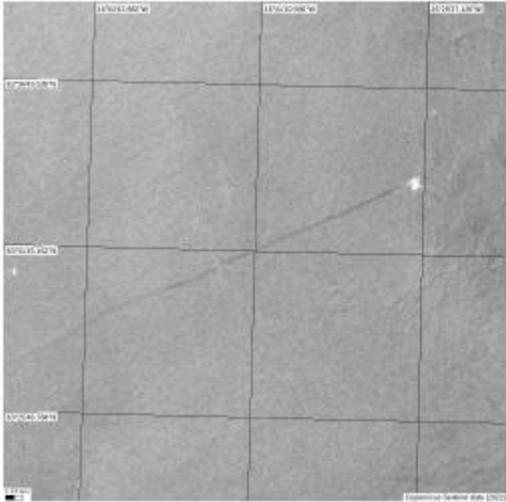
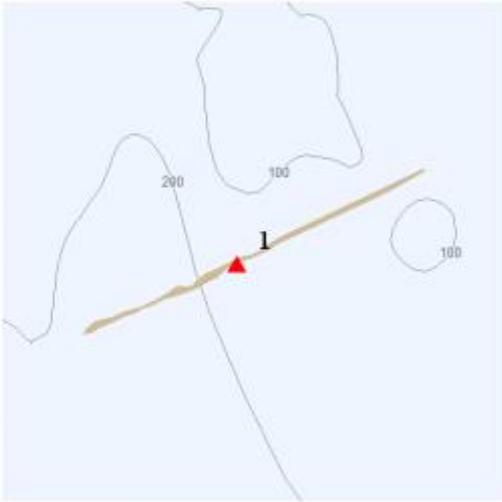
37	2022-08-20 07:34:51Z	63°30.49'N	016°44.59'W	5.482589	1	A	<p><b>On-site observation.</b> Nothing observed. A cruise vessel connected to the possible oil spill detection was identified. The vessel had been discharging grey water (from accommodation, laundry, galley) and food waste according to MARPOL. The fixed wing surveillance aircraft TF-SIF was dispatched and after a slight delay due to a search and rescue case, it proceeded to the position and took a SLAR image on-site about 5 hours after the image was taken. Nothing was observed.</p>

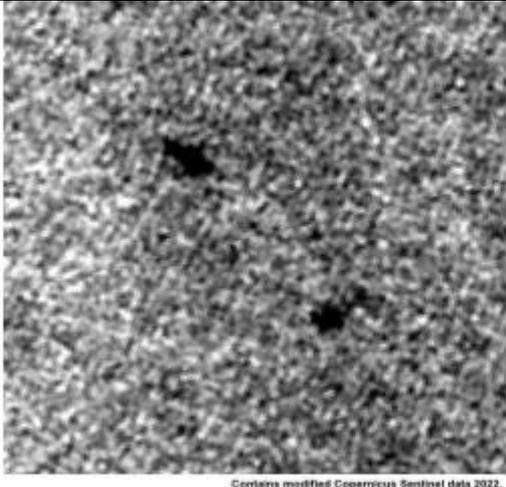
38	2022-08-20 18:50:41Z	62°09.84'N	018°33.06'W	0.222752	2	A	<b>Reason for no verification:</b> Considered a lookalike. No vessel could be aligned with the detection.

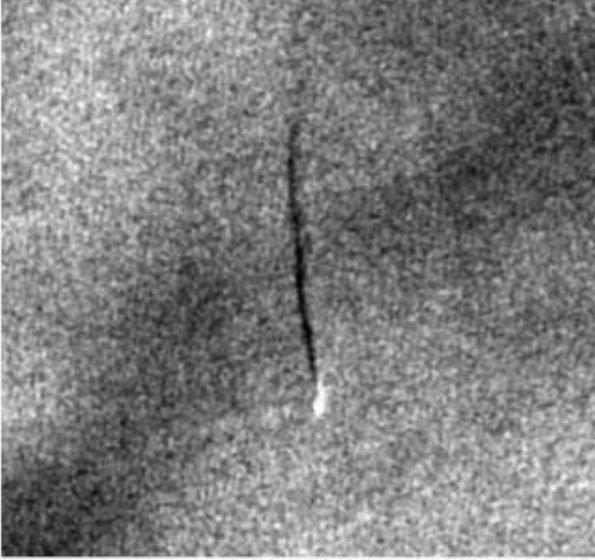
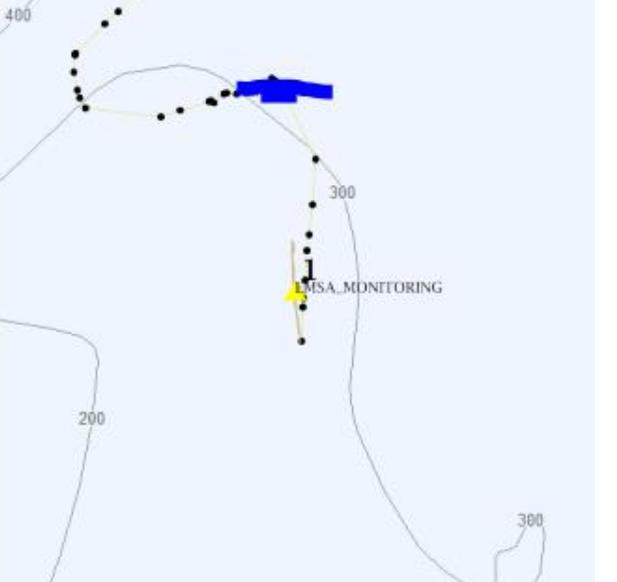
48	2022-08-29 07:10:21Z	66°49.98'N	006°41.82'W	0.611974	2	A	<b>Reason for no verification:</b> Considered a lookalike. Several pelagic fishing vessels are in the area fishing for mackerel with some blue whiting with fatty liver as by-catch.
49	2022-08-29 07:10:21Z	66°52.33'N	006°33.11'W	0.689989	2	A	<b>Reason for no verification:</b> Considered a lookalike. Several pelagic fishing vessels are in the area fishing for mackerel with some blue whiting with fatty liver as by-catch.
50	2022-08-29 07:10:21Z	67°02.77'N	006°40.38'W	1.967895	1	A	<b>Reason for no verification:</b> Considered a lookalike. Several pelagic fishing vessels are in the area fishing for mackerel with some blue whiting with fatty liver as by-catch.
51	2022-09-01 18:51:58Z	66°46.35'N	019°23.57'W	0.522336	1	B	<b>Reason for no verification:</b> Considered a lookalike. The fishing vessel aligned with the detection says that approximately 10 liters of fish liver had gone overboard through the pump.

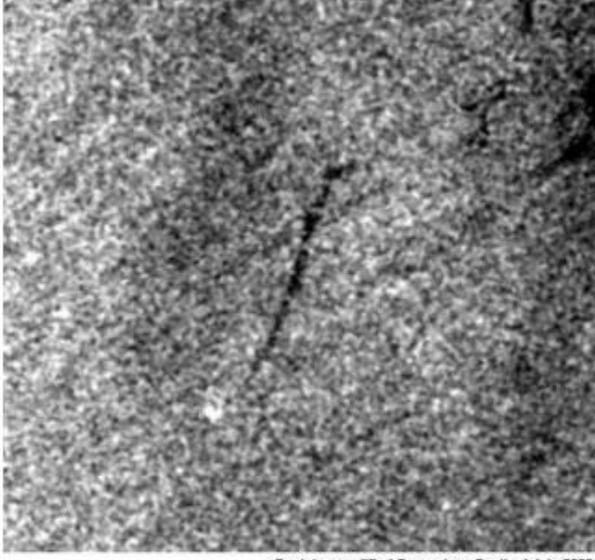
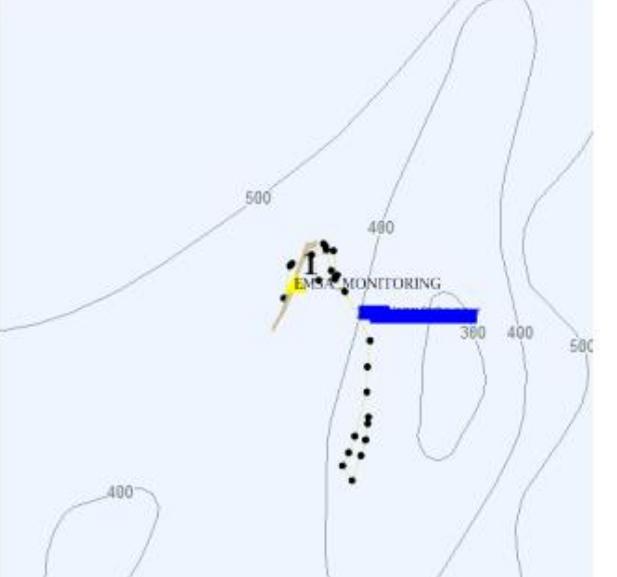
52	2022-09-03 18:35:50Z	67°42.44'N	018°41.88'W	0.85519	1	B	<p><b>Reason for no verification:</b> Considered a lookalike. The fishing vessel aligned with detection had been processing the catch, which is considered the most likely cause. Three hours earlier the vessel had been discharging bilge water through its oily water separator.</p>

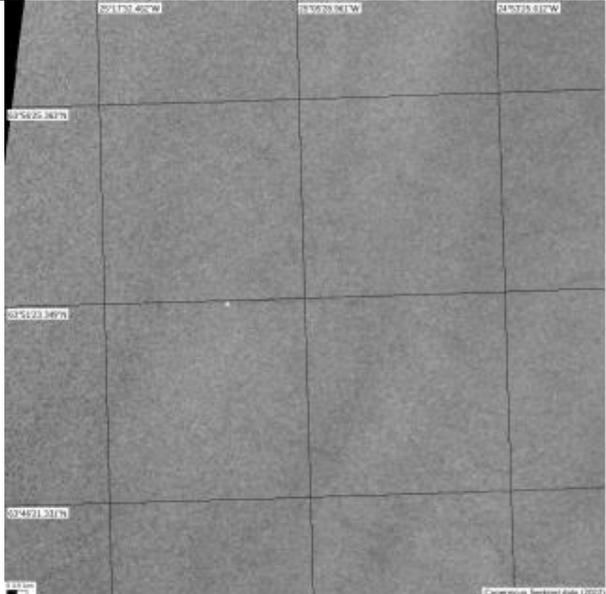
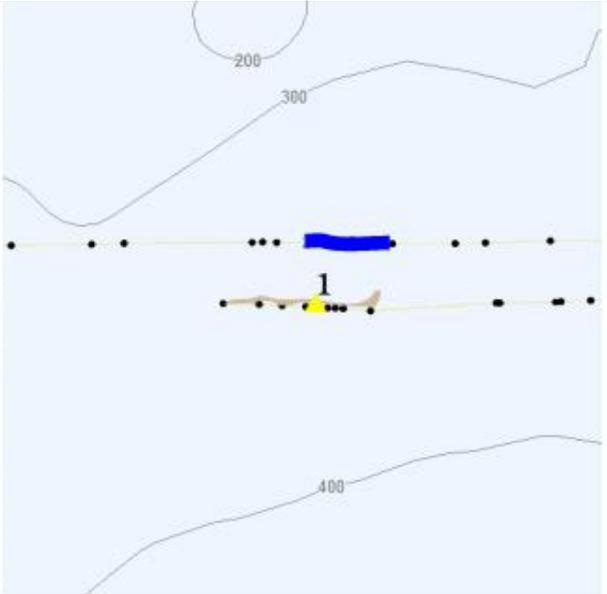
53	2022-09-04 07:59:14Z	63°51.34'N	025°05.8'W	1.315456	1	B	<p><b>Reason for no verification:</b> Considered a lookalike. The longliner aligned with the detection investigated but did not find any</p>

reason for the detection. The Institute of Earth Sciences of the University of Iceland assessed that the current conditions with very little wind and clear signs of organic matter in the ocean could easily course false positives.

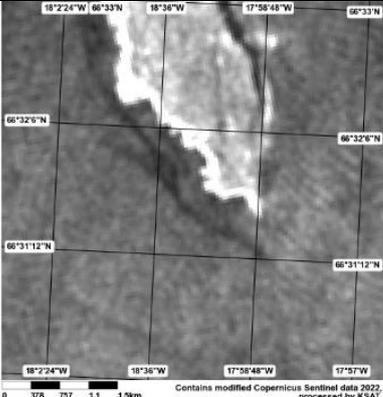
62	2022-10-02 07:26:40Z	65°55.06'N	012°49.05'W	1.535485	1	B	<b>Reason for no verification:</b> Considered a lookalike. The pelagic fishing vessel aligned with the detection was pumping it's catch on board at the time the of acquisition.
63	2022-10-21 18:35:31Z	66°31.62'N	018°00.08'W	0.515271	1	B	<b>Reason for no verification:</b> Considered a lookalike. No ships' traffic aligned with detection. The port in Grimsey hadn't observed any pollution but reported a lot of algae in the area.

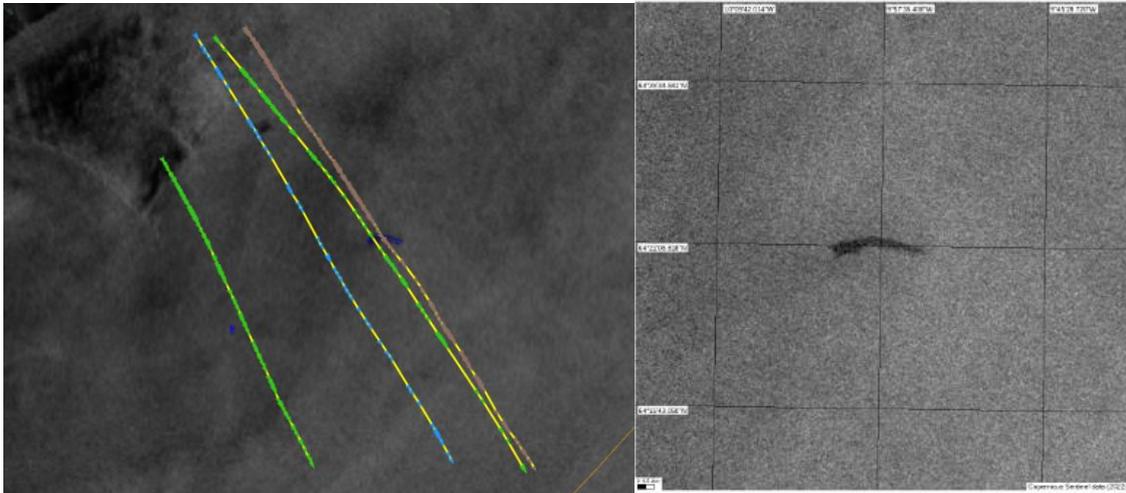
65	2022-10-22 08:17:36Z	66°46'N	024°40.38'W	10.141798	3	B	Same as above.
66	2022-11-05 18:59:29Z	64°02.5'N	022°43.99'W	0.492885	1	B	<b>On-site observation:</b> Considered a lookalike. The detection was connected to the North side of Sandgerdi port. Port authorities did not observe anything abnormal. They sent pictures from the area showing a groundwater outlet. Different densities of water is likely to have caused the detection.
67	2022-11-09 07:10:21Z	64°21.05'N	009°58.79'W	4.341148	1	A	<b>Reason for no verification:</b> No assets available. The coast guard surveillance aircraft TF-SIF was deployed abroad. Two vessels on a SE

course sailed through this class A possible oil spill 7-8 hours earlier. The detection was 6 km long and 1,5 km wide.

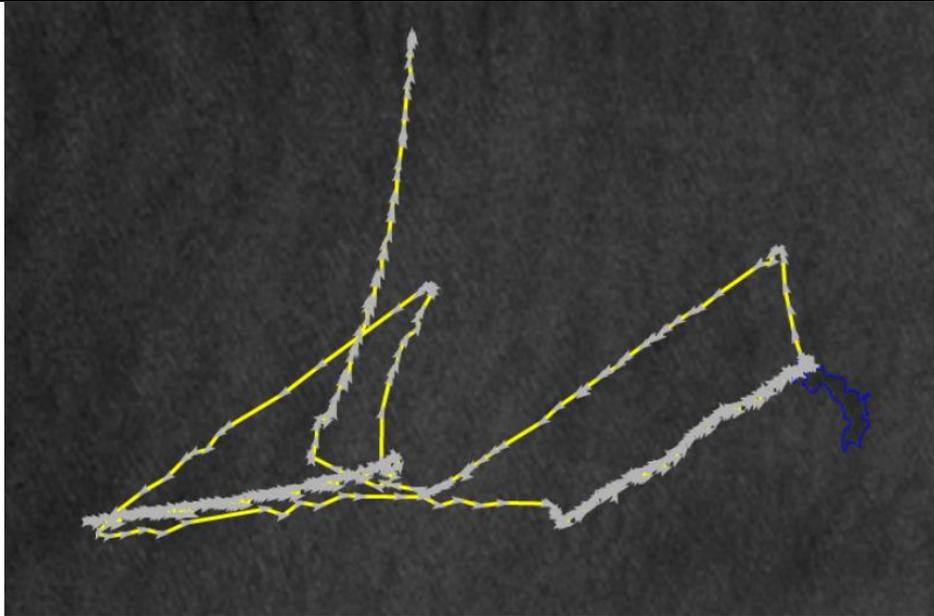
<p>SafeSeaNet Ecosystem GUI EMSA, CleanSeaNet, Sentinel 1</p>						
68	2022-11-12 18:52:04Z	67°14.75'N	017°52.03'W	0.792905	1	B	<b>Reason for no verification:</b> Considered a lookalike. The aligned gillnetter was fishing for Greenland halibut had been washing the deck. The Greenlandic halibut is considered a fatty fish.

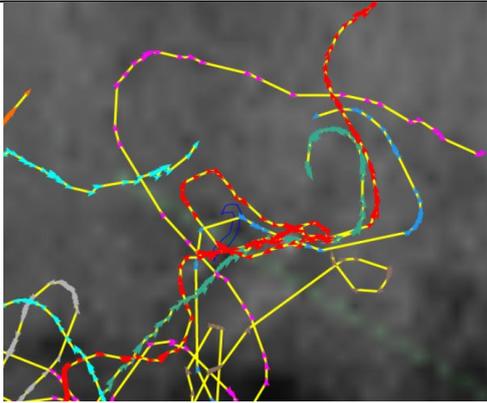
<p>SafeSeaNet Ecosystem GUI EMSA, CleanSeaNet, Sentinel 1A</p>						
69	2022-11-26 07:18:29Z	65°27.89'N	009°22.24'W	0.558651	1	B	<b>Reason for no verification:</b> Considered a lookalike. Several pelagic fishing vessels fishing for herring in the area.

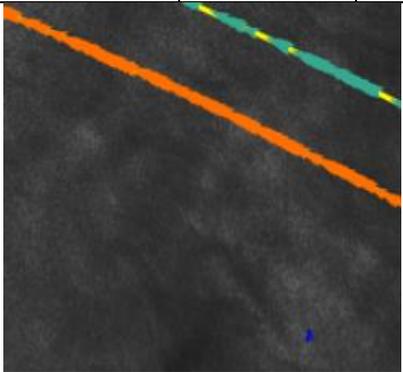
SafeSeaNet Ecosystem GUI EMSA, CleanSeaNet, Sentinel 1						
70	2022-11-26 07:18:29Z	65°07.24'N	008°16.25'W	0.574143	1	B	<b>Reason for no verification:</b> Considered a lookalike. No vessels in area.
71	2022-11-29 19:00:06Z	66°29'N	020°39.61'W	0.088249	1	B	<b>Reason for no verification:</b> Considered a lookalike. The vessels in the area were too far away to align with the possible oil spill. Distance 5 nm; time 1,3 h. On 2 December, the Icelandic Coast Guard helicopter was sent on patrol to the area, where it observed sharp differences in temperature of water masses in the area. Observations were conducted with infrared camera.

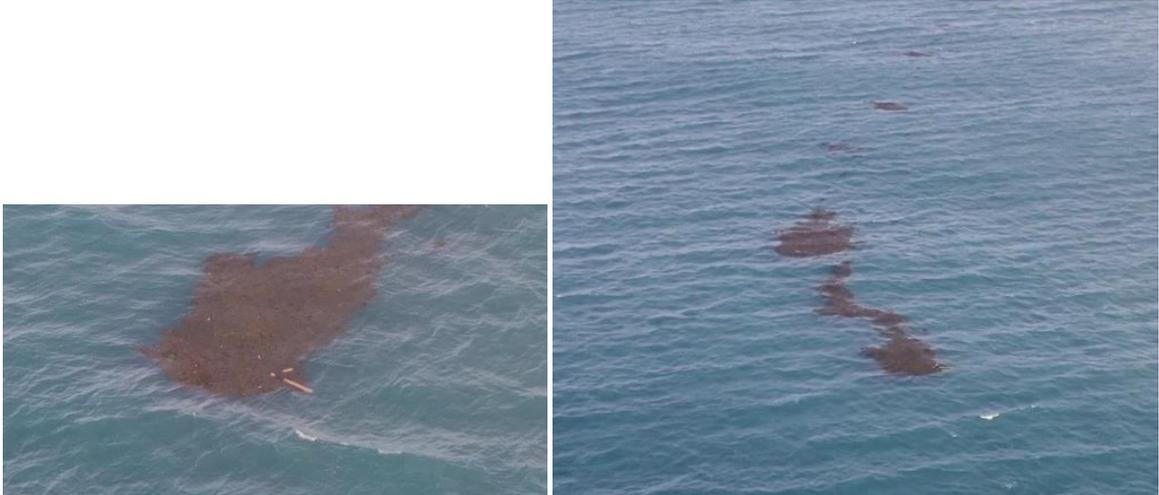
Maritime Incidents, Stranded or Sunk Ships and Marine Pollution Reported (not included above)	
Date	Event
26 Jan	Open boat stranded at Engøy, the boat was towed to port. No pollution reported.
18 Feb	Confirmed lookalike. Air Traffic Control reported a possible oil spill about 5 nm from shore in vicinity of Reykjavik. The coast guard helicopter investigated the possible oil spill, which was assessed as seaweed. Considered a lookalike.

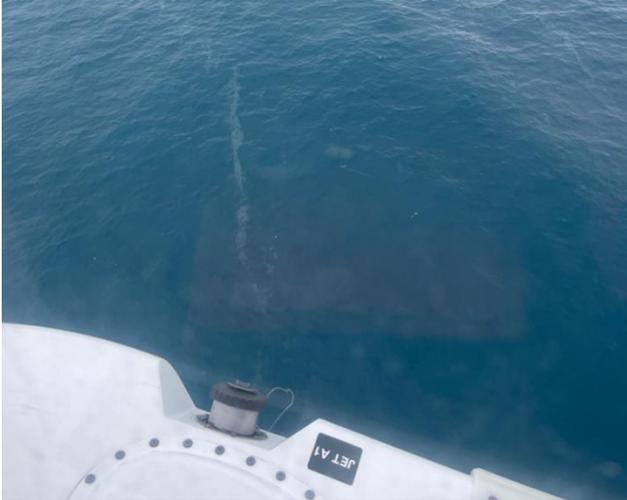
19 Feb	Possible marine pollution reported in Dyrafjordur connected to dead salmon from fish farm washing up on the beach. The Environment Agency and the Food and Veterinary Authority were informed.
23 Mar	A possible oil sheen was detected by helicopter during a patrol flight. Maritime traffic in the area couldn't be aligned with the detected possible oil spill.
